# ENDANGERED WILDLIFE TRUST

## Wildlife and Energy interactions: A South African perspective -2

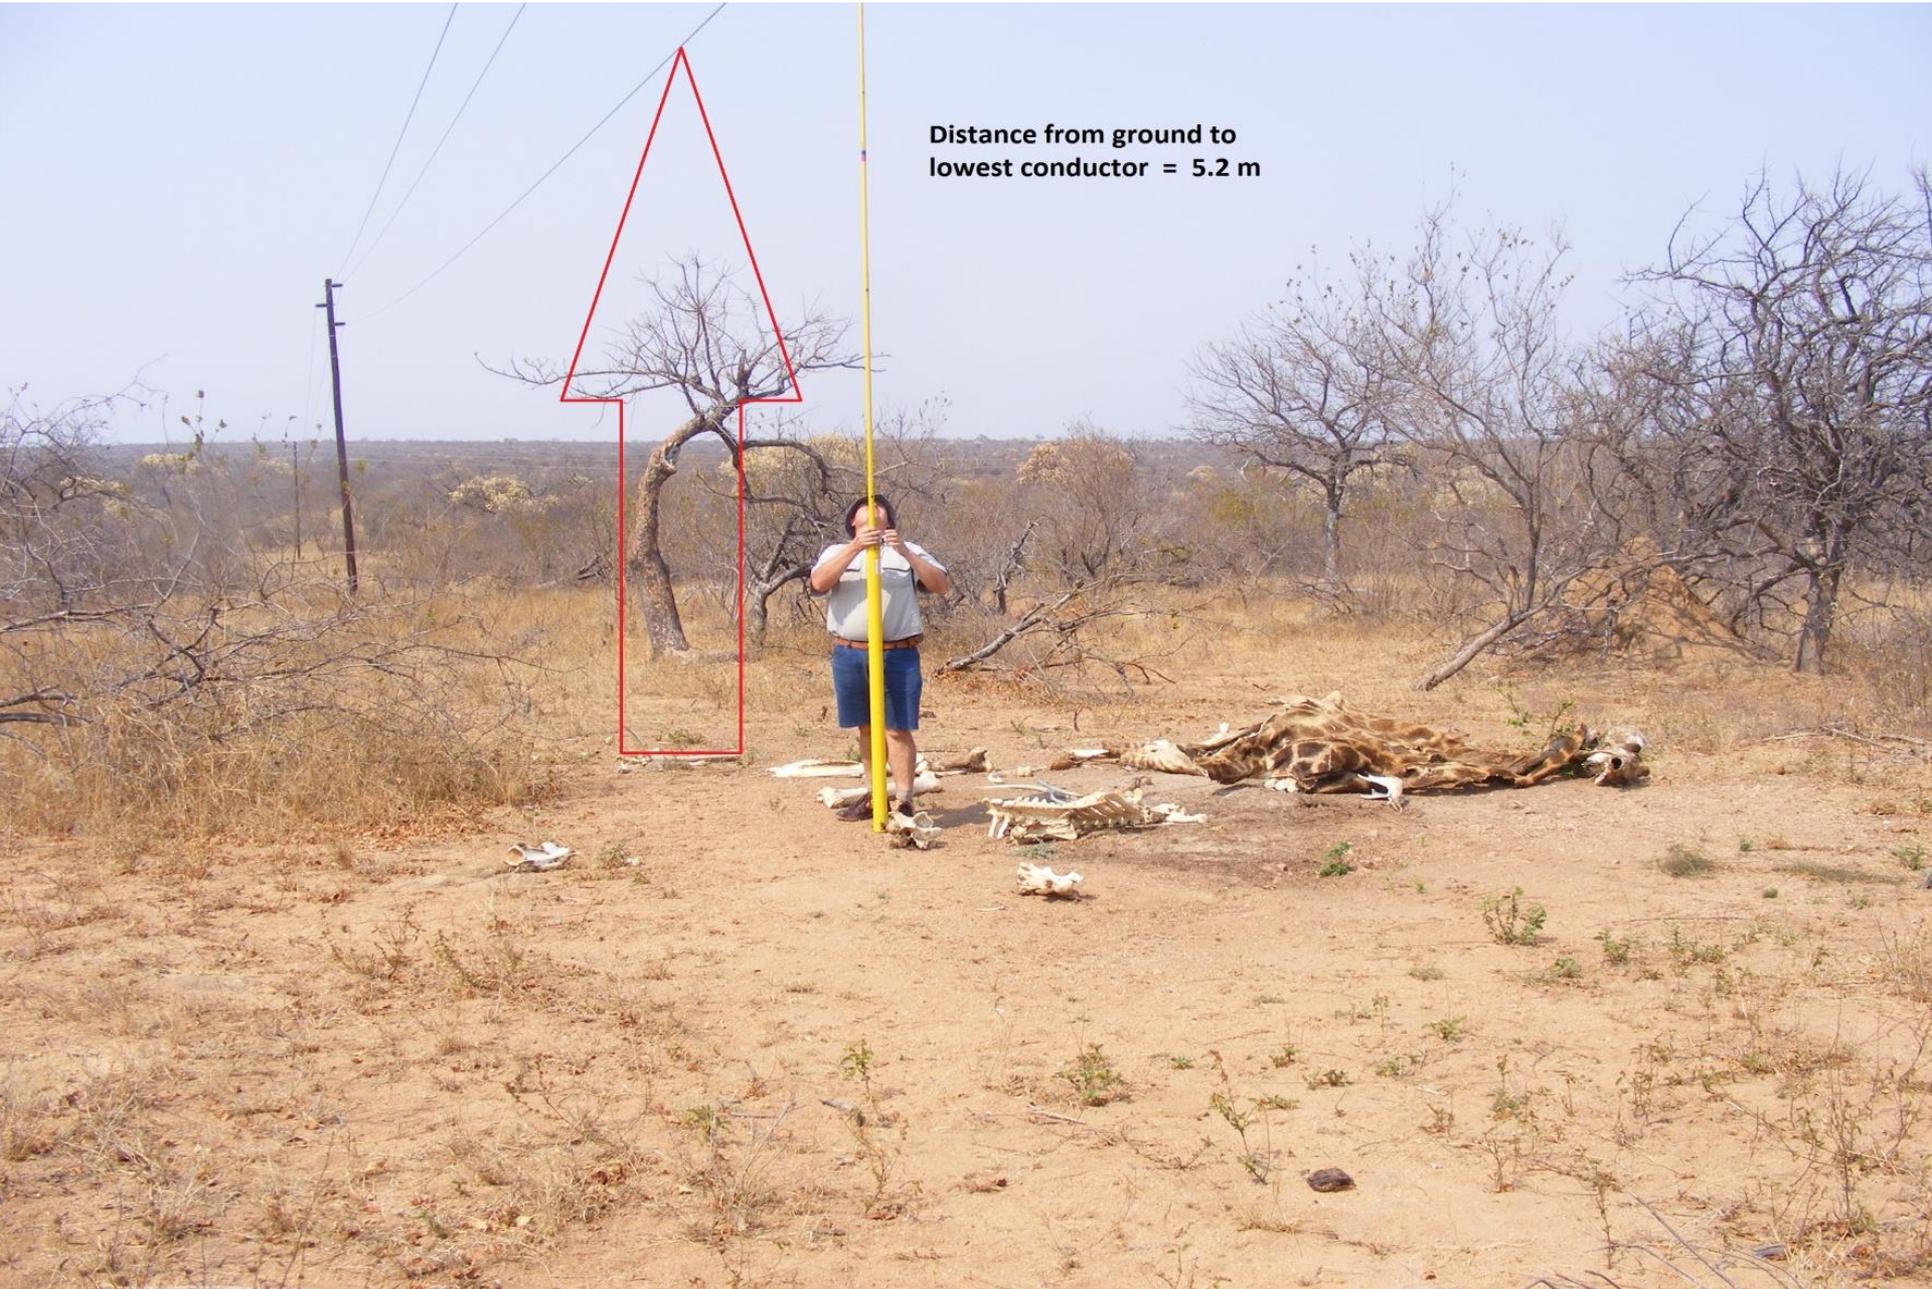
**Distance from ground to  
lowest conductor = 5.2 m**

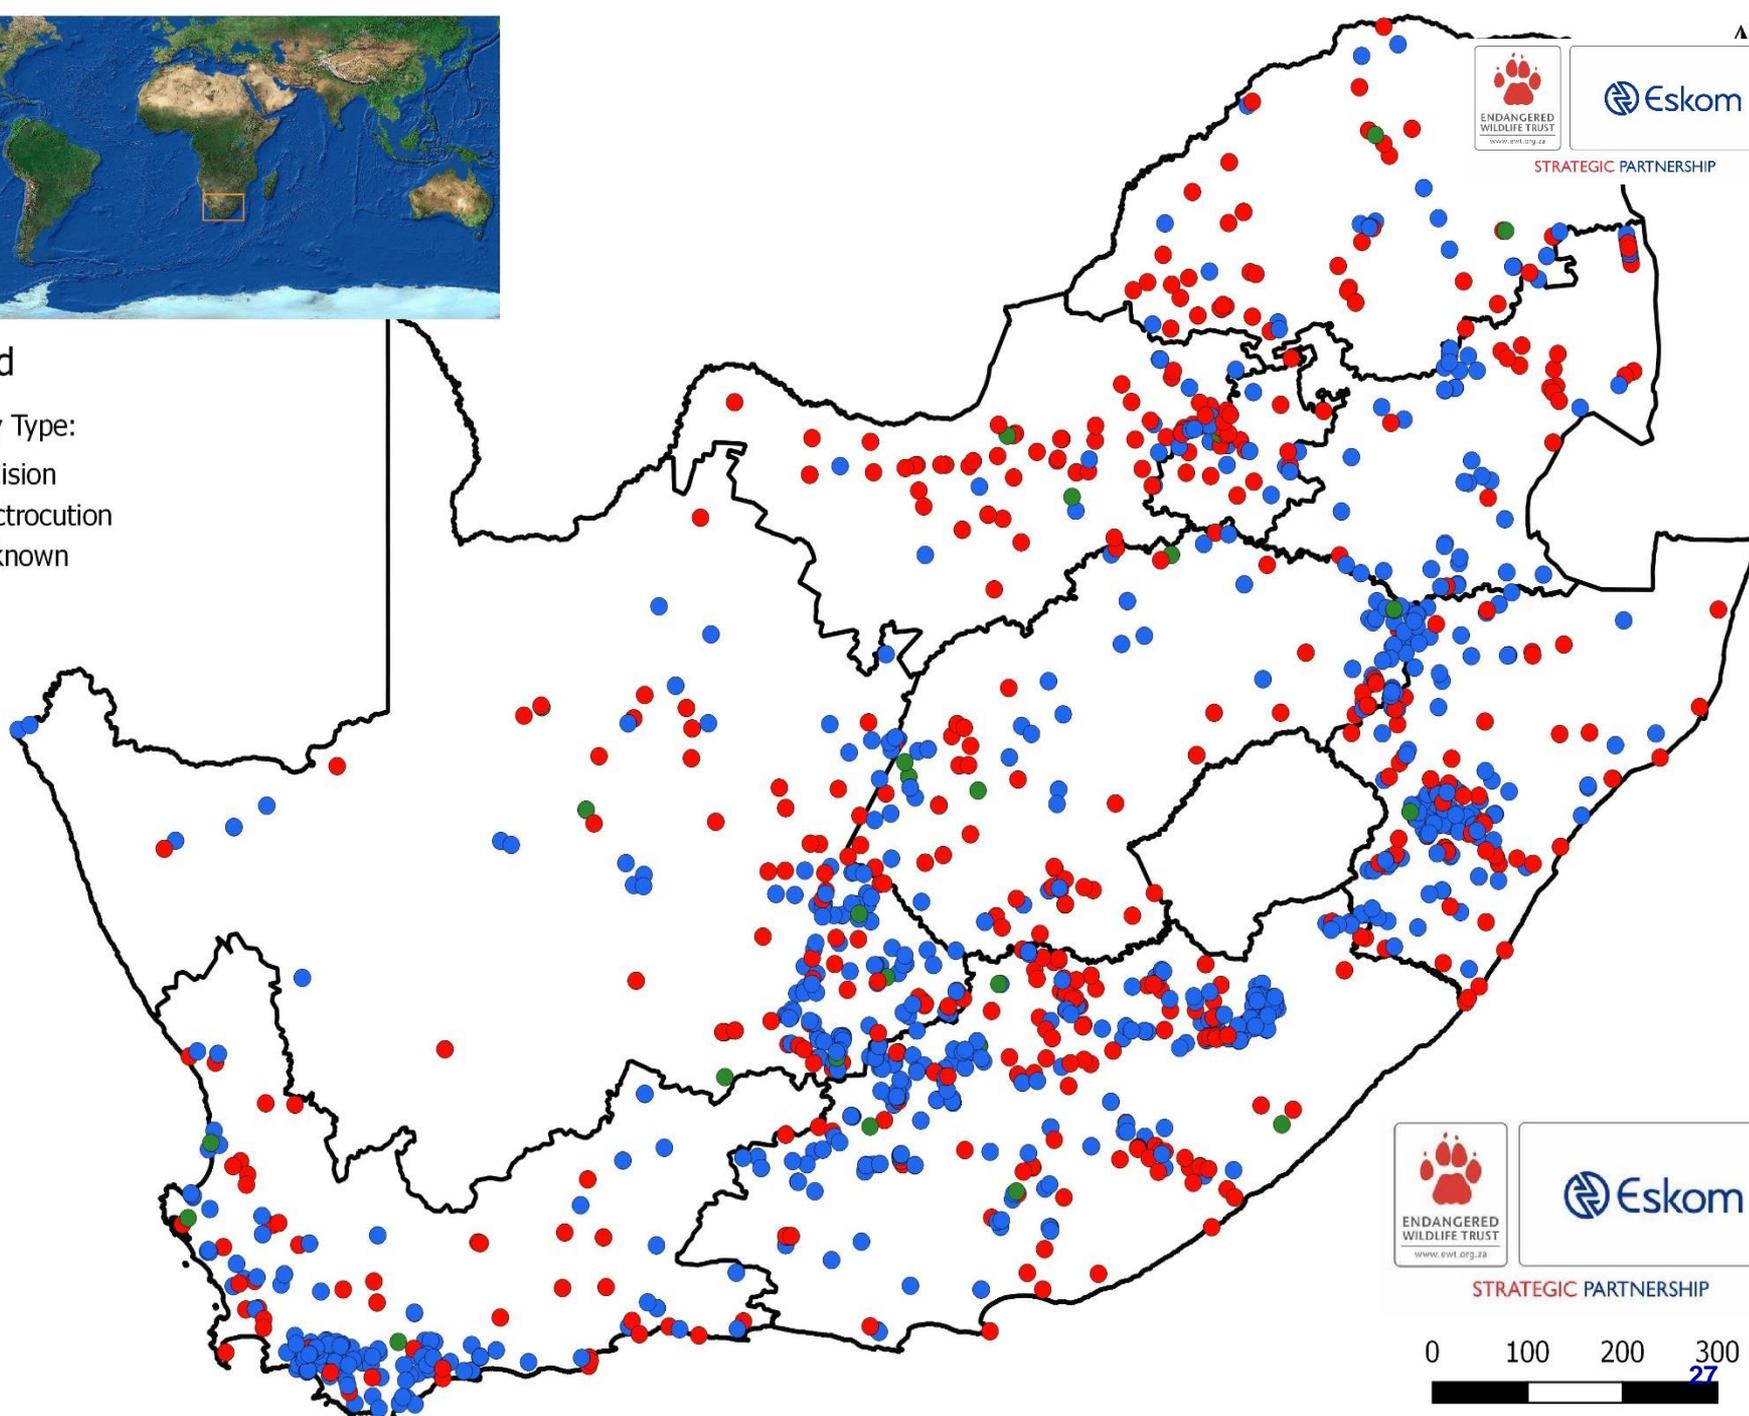
## Legend

Mortality Type:

- Collision
- Electrocution
- Unknown

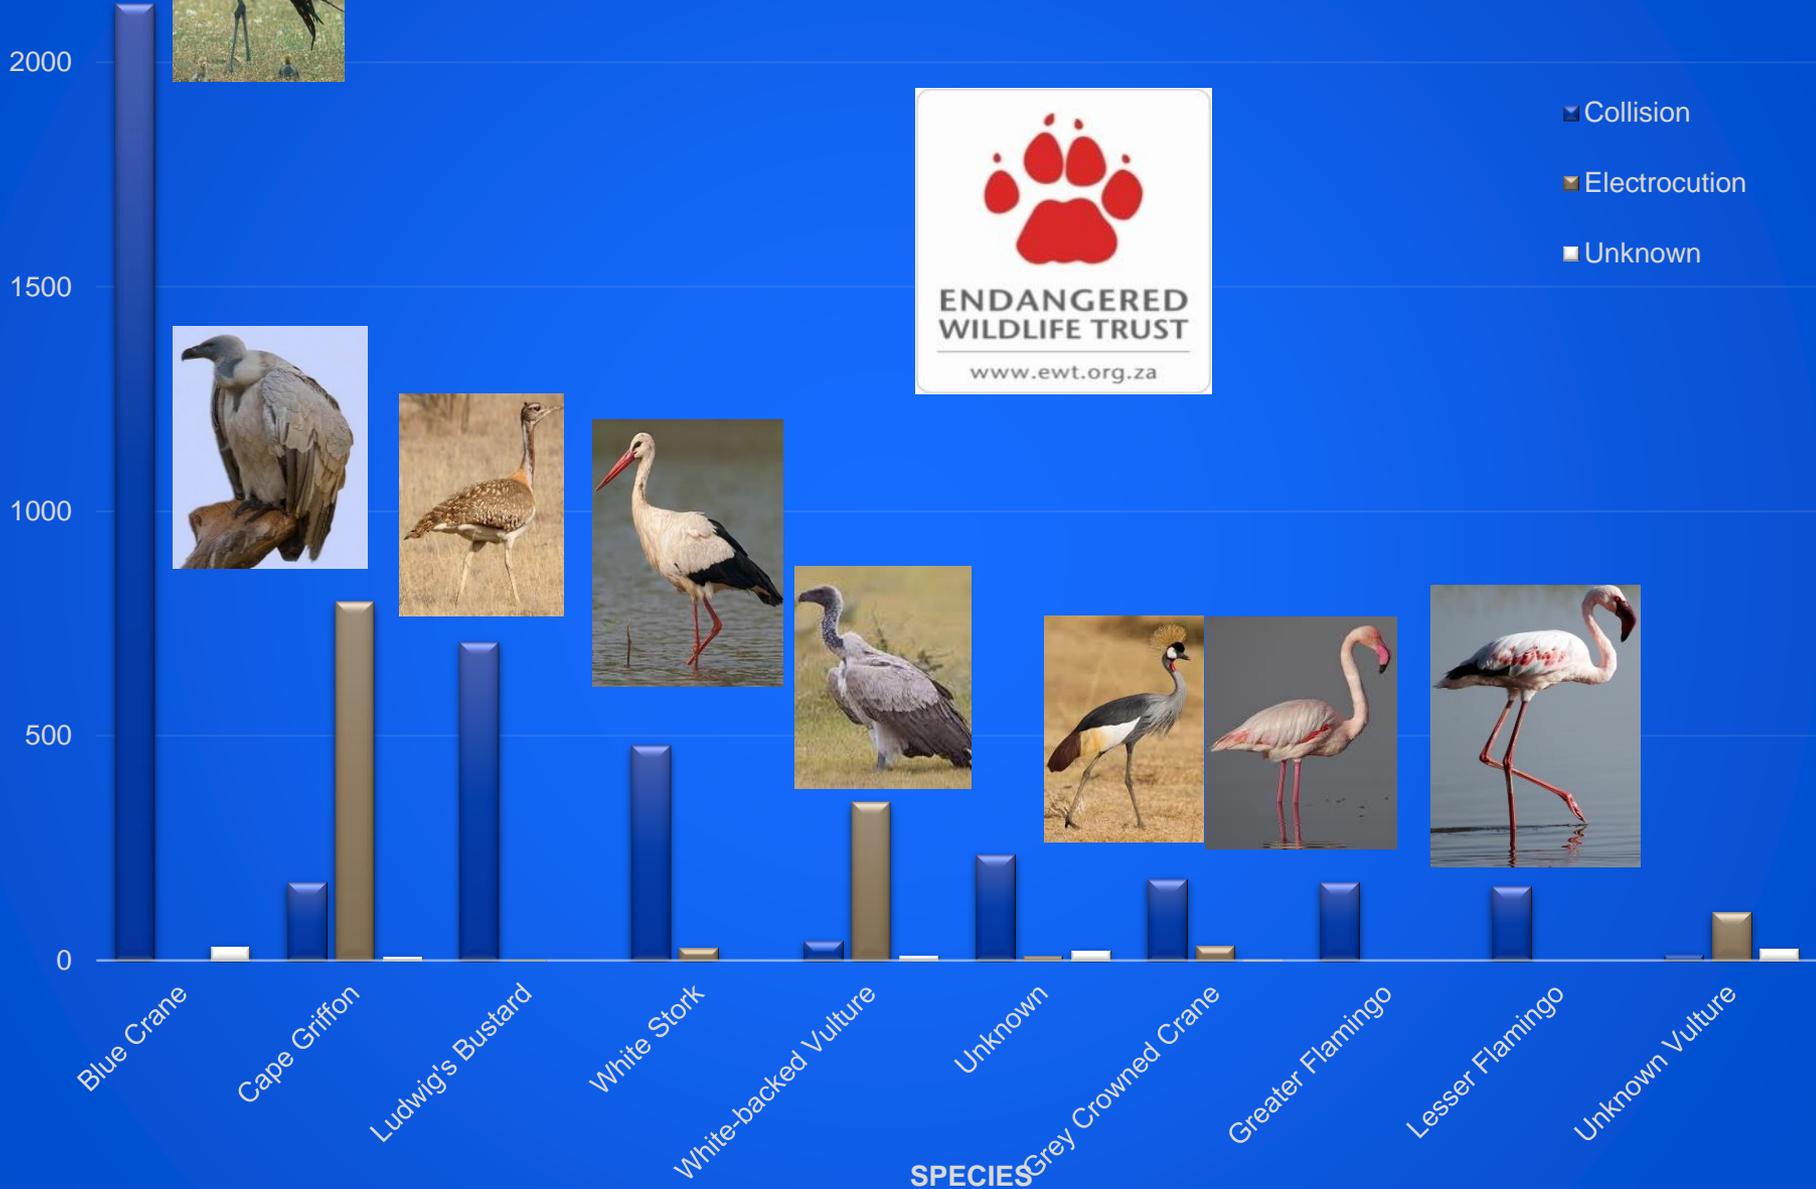
# Top 10 Species

NUMBER

Collision
-

Electrocutation
-

Unknown

Blue Crane

Cape Griffon

Ludwig's Bustard

White Stork

White-backed Vulture

Grey Crowned Crane

Greater Flamingo

Lesser Flamingo

Unknown Vulture

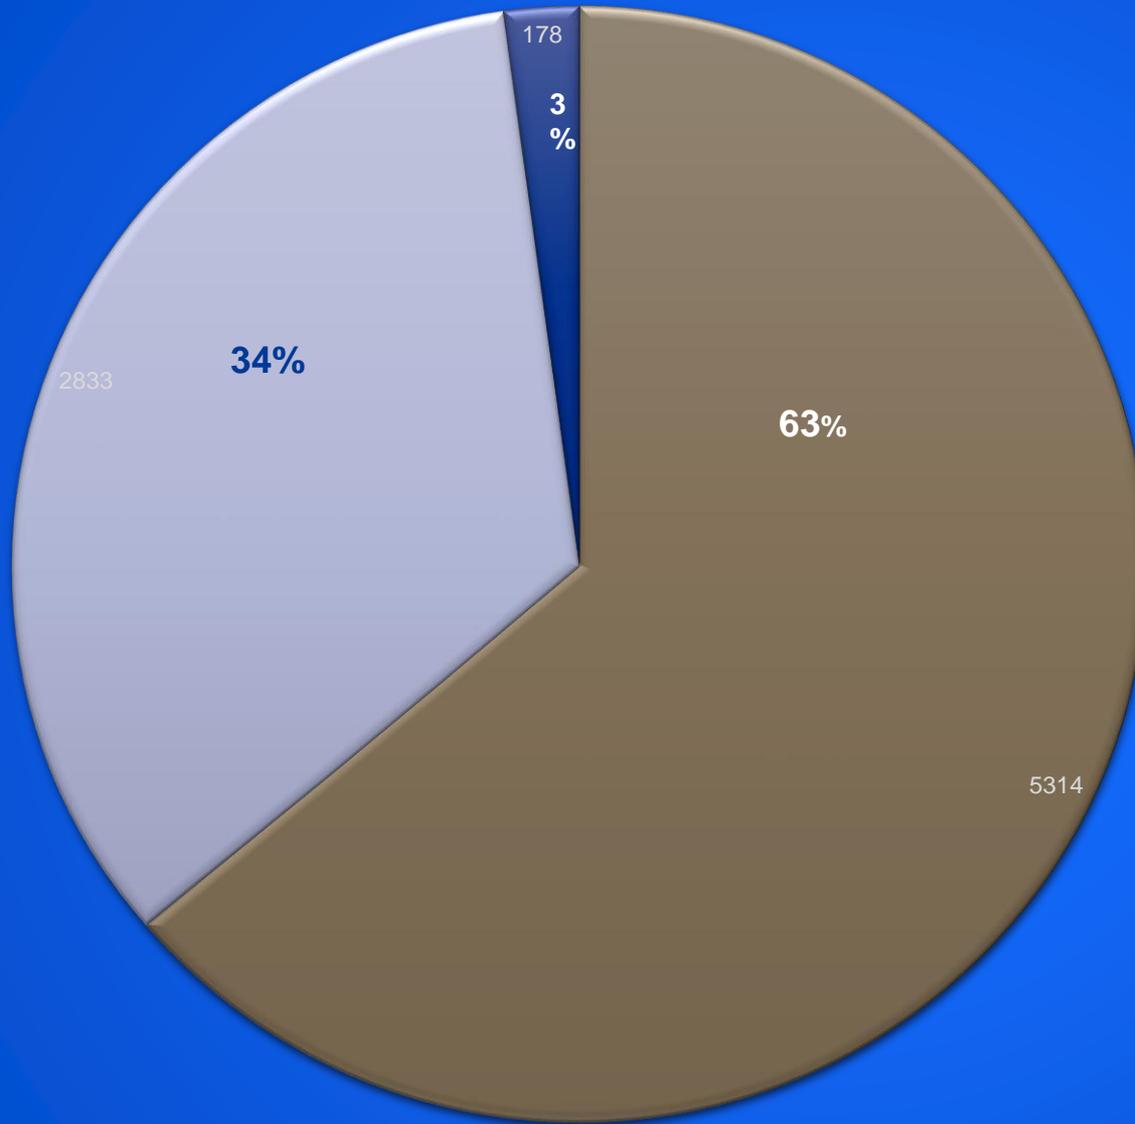
# Mortality Types

**Total  
mortalities :  
8325**

■ Collision

■ Electrocutation

■ Unknown

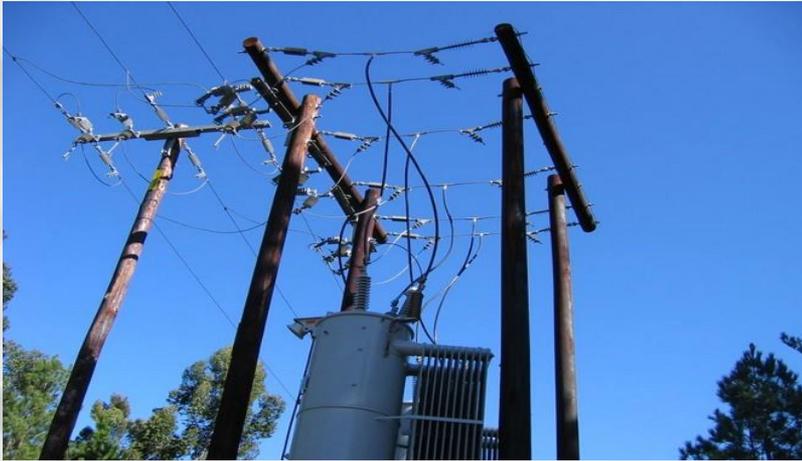
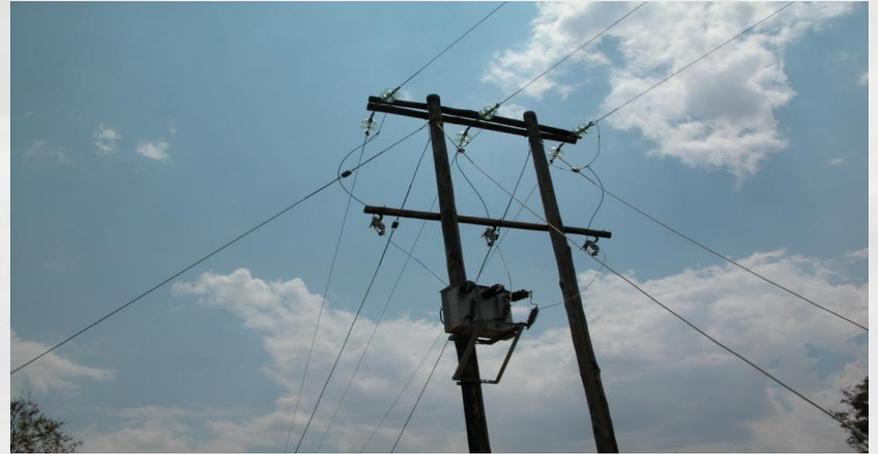
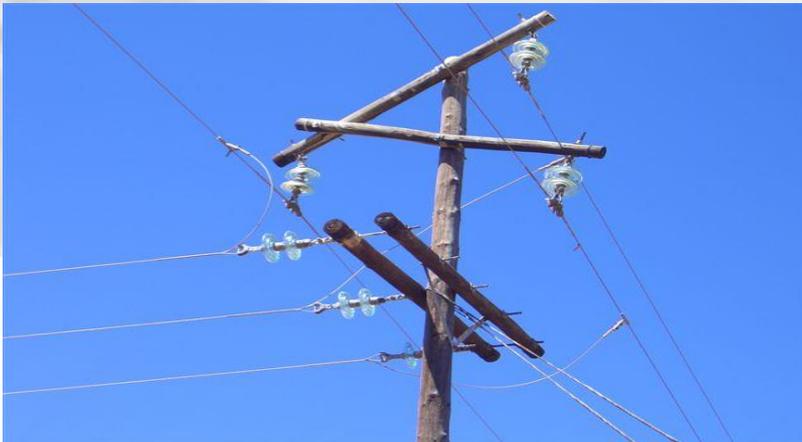
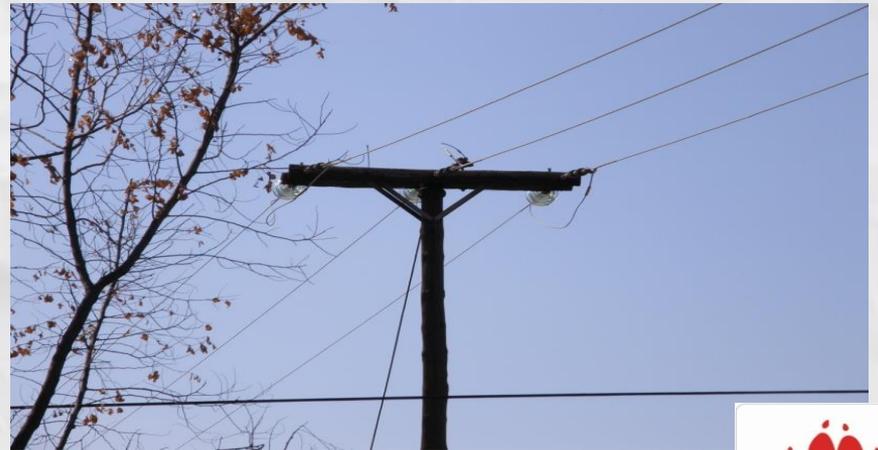
## Structure Type

# Photographs

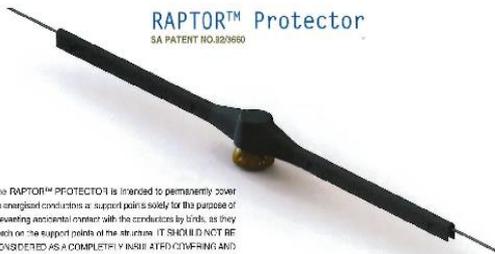
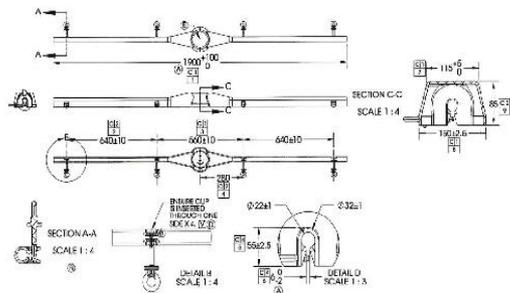
## RAPTOR™ Protector

The RAPTOR™ PROTECTOR is intended to permanently cover an emergency condition as a support pin is solely for the purpose of preventing accidental contact with the conductors by birds, as they perch on the support points of the structure. IT SHOULD NOT BE CONSIDERED AS A COMPLETELY VISIBLE AFD COVERING AND SHOULD NOT BE USED AS A COVER UP DEVICE TO PROTECT HUMANS FROM ELECTRICAL SHOCK.

The RAPTOR™ PROTECTOR consists of:

- One finished aluminum product approximately 2 000 mm in length;
- Automatic clipping device for securing the component onto the insulator and conductor.

This complete product will fit over all types of distribution insulators currently in use, and conductors up to and including 16 mm OD.

Catalogue No.: RPL 03

Material: Flow Molded Alkathene.

Notes: Automatic clipping devices to clamp firmly onto conductor dia. range 8 mm to 16 mm.

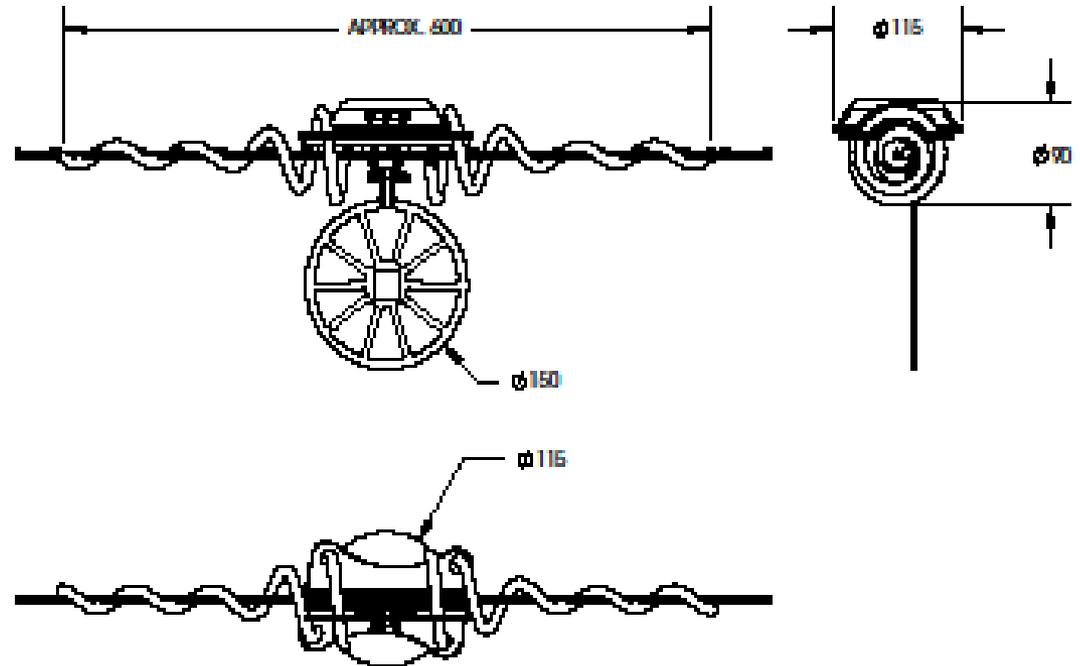
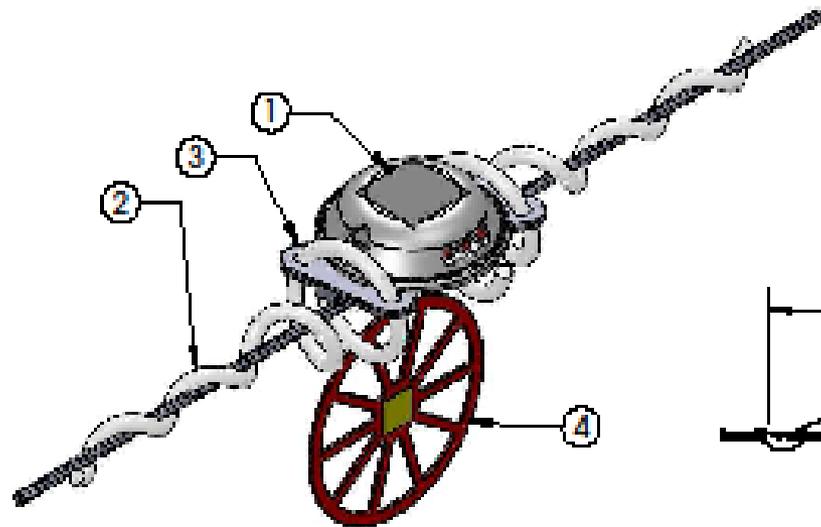
<b>CUSTOMER DRAWING TITLE</b>					<b>TOLERANCES UNLESS NOTED</b> 0.1 0.01 0.25 0.00 0.1 ANGLES ±1°	<b>UNITS</b> mm <b>DO NOT SCALE</b> THIRD ANGLE PROJECTION 
<b>CONCEPTUAL SOLAR LED BIRD FLIGHT DIVERTER</b>

ITEM NO.	PART NUMBER	DESCRIPTION	QTY.
1	BFOLED-000X	SOLAR LED LIGHT	1
2	BFOLEDL	PVC HELICAL ATTACHMENT	2
3	BFOLED-02	BFOLED NYLON BASE PLATE	1
4	BFL-06	NYLON FLAPPER	1
5	M6X36BT10SSST	M6 X 36 STAINLESS STEEL BOLT 10MM THREAD	1
6	M6NYLUTSST	M6 STAINLESS STEEL NYLOCK NUT	1

- CONCEPTUAL DESIGN MAY BE SUBJECT TO ALTERATION
- 5 YEAR BATTERY LIFE ON SOLAR CELLS
- LED WARNING LIGHTS EFFECTIVE AFTER DAY LIGHT HOURS.

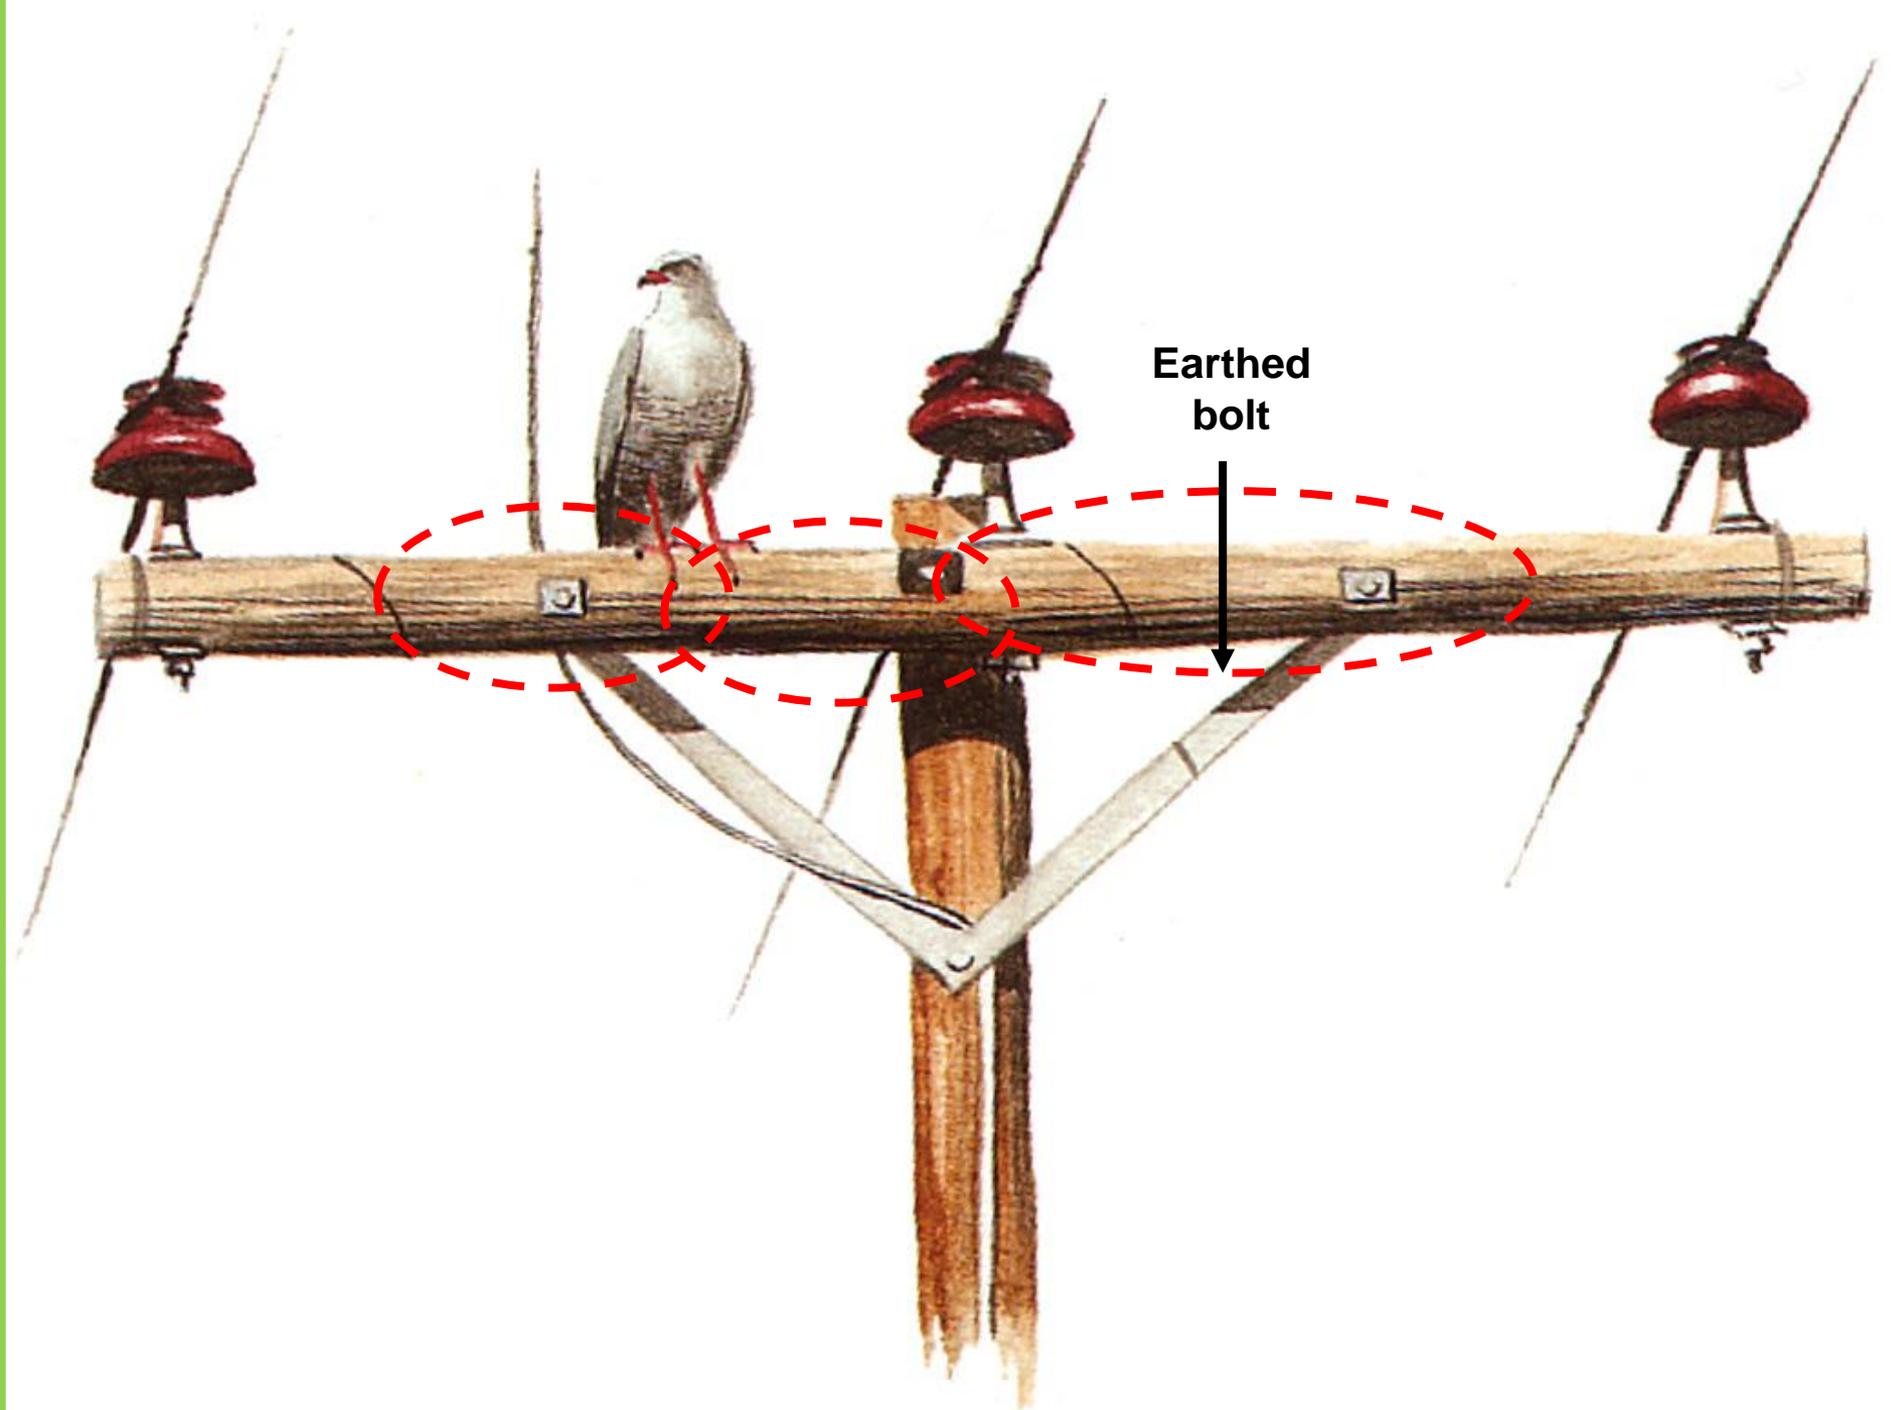
Earthed  
bolt

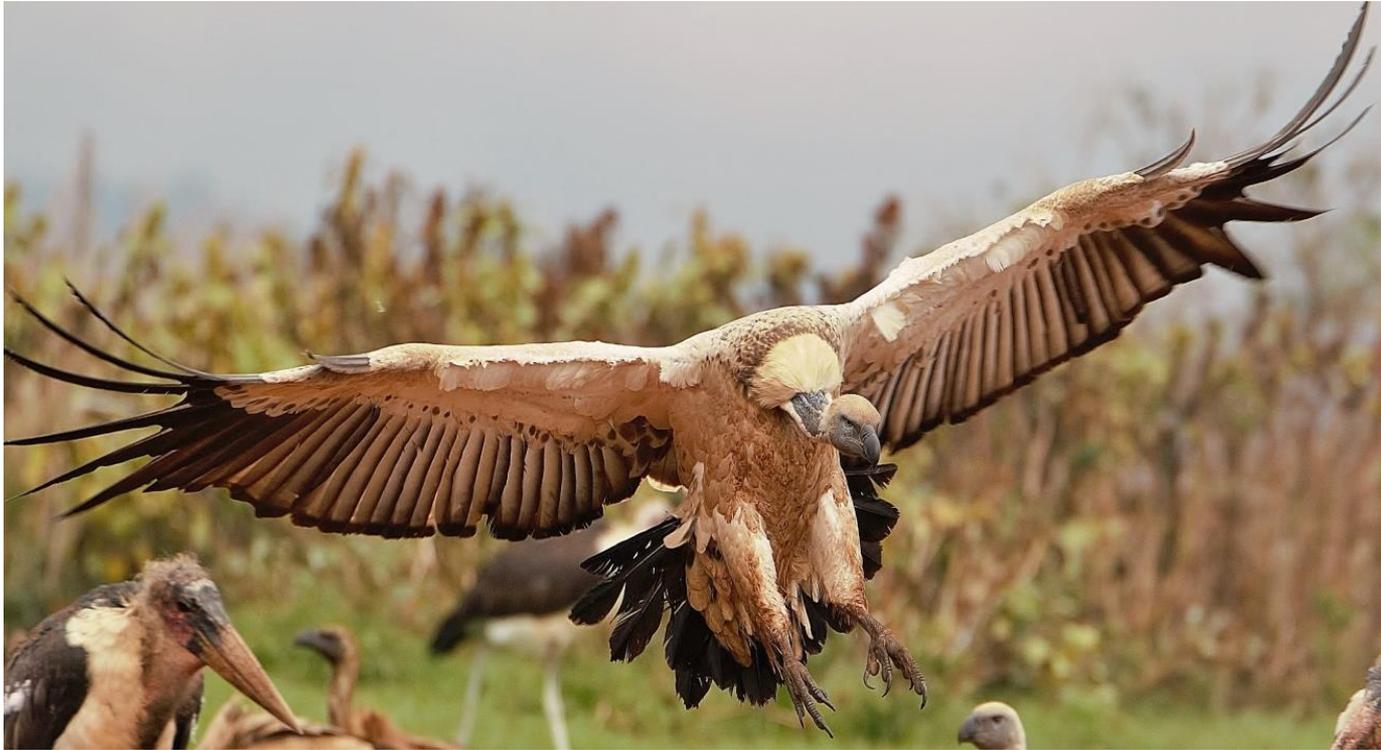
# Vulture Anatomy

- Wide – Wingspan of up to 2.8 m

Fortunately not all of the wing is conductive, dry feathers have very high resistance. (Beutel, McLaren, Hoogstad et al)

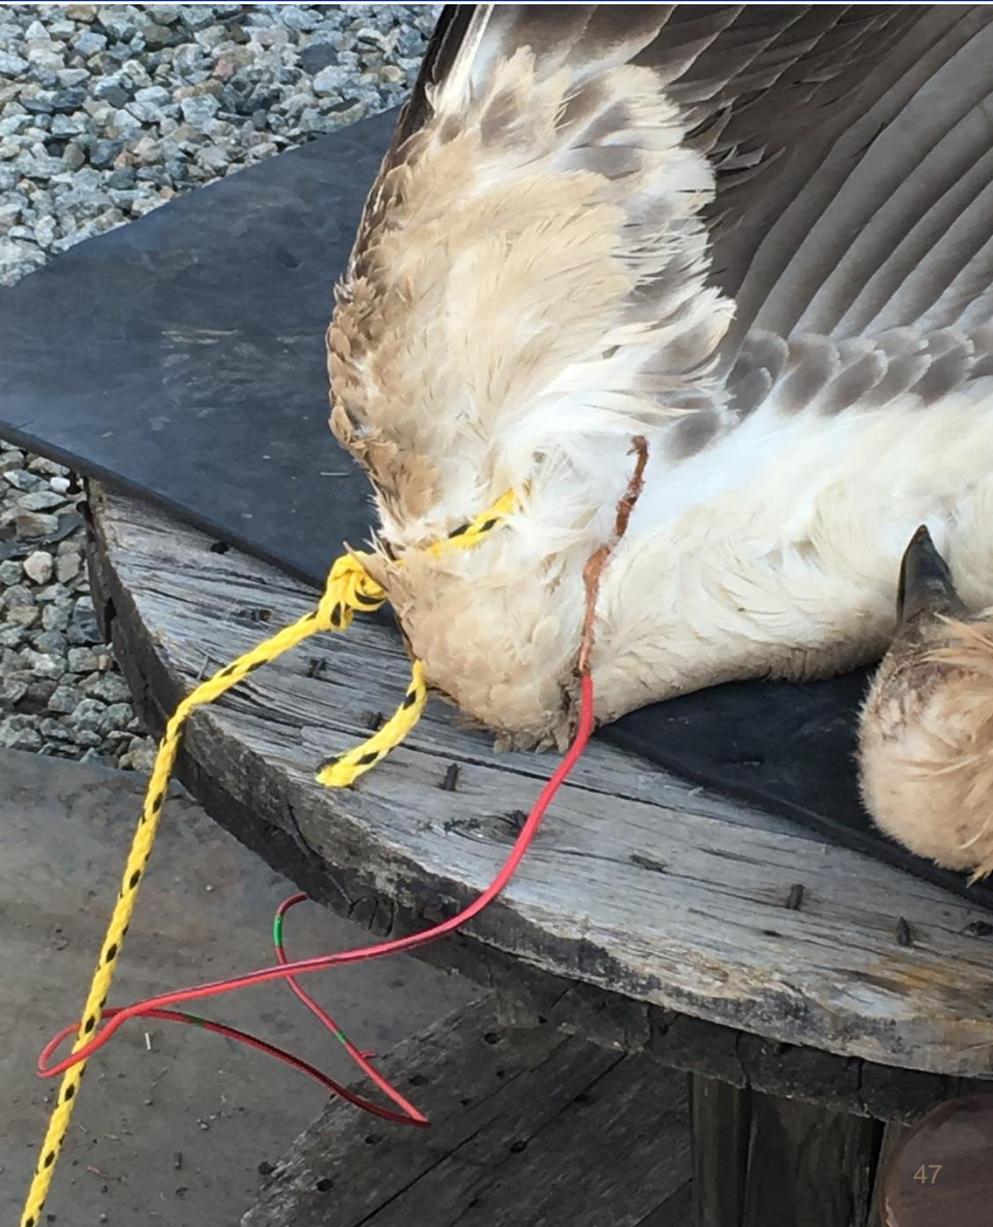
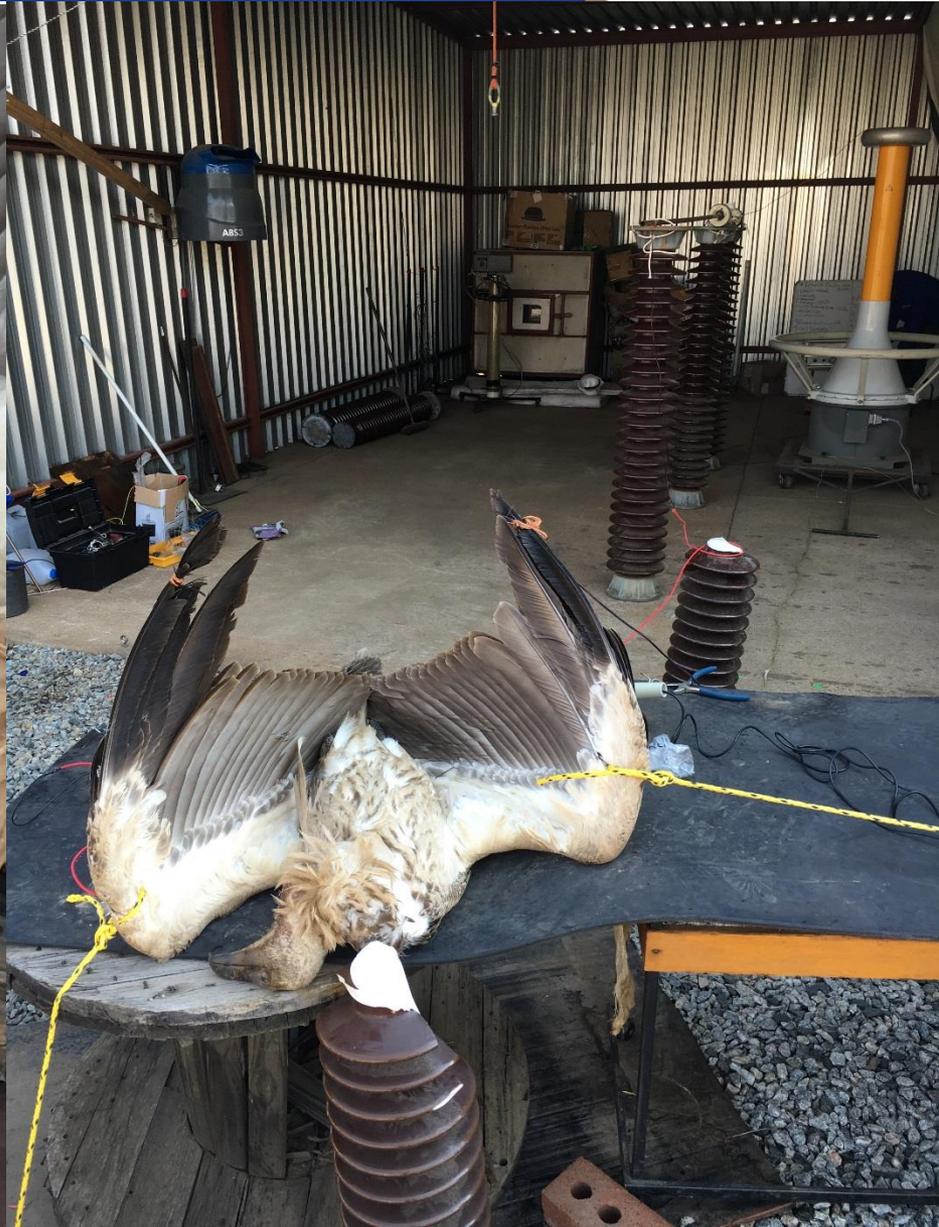
# Impedance testing

- Wingspan adds to 'height'

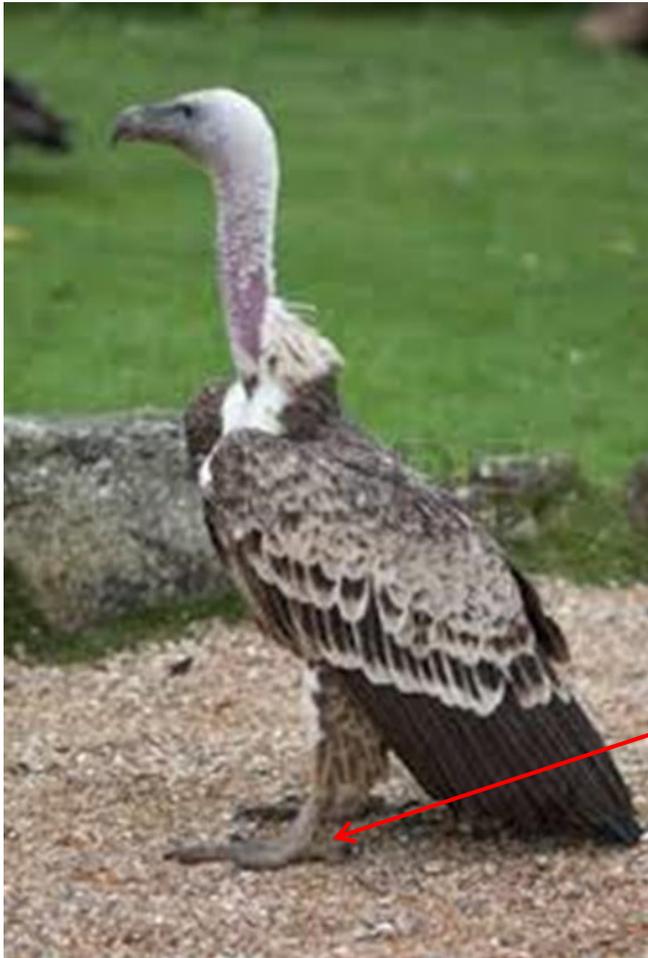
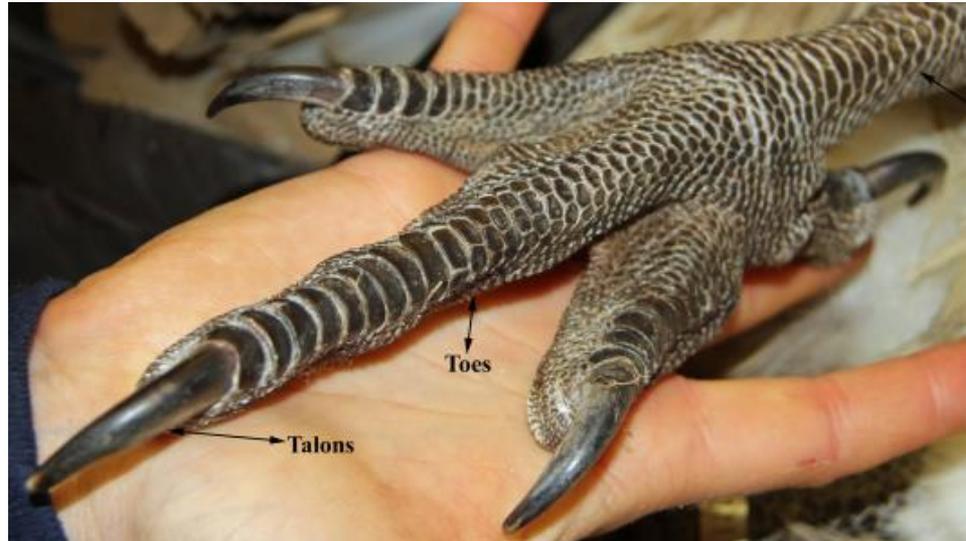
# Vulture Anatomy

- High – Tall when stretching – can reach up to 1.1m

Big feet with relatively small claws – designed more for walking on the ground than gripping branches (conductors)

Makes it clumsy when trying to perch.

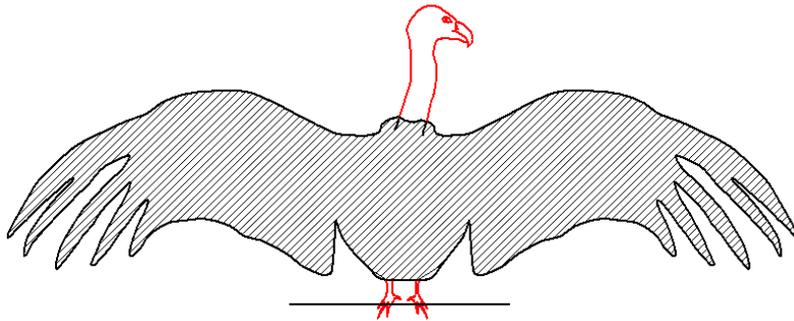
# Clearance Test Methodology 'Turkey Test'

'DRESSED' BIRD

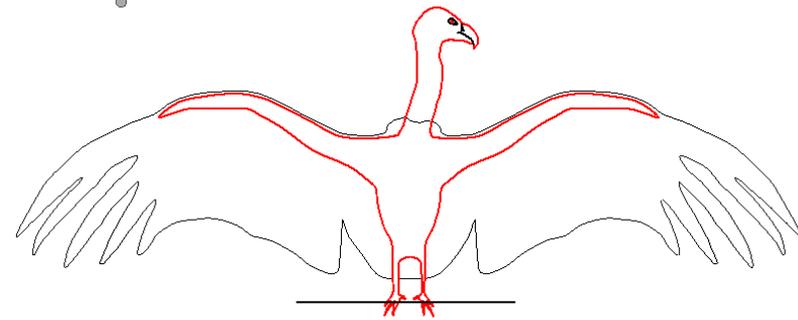
'UNDRESSED' BIRD

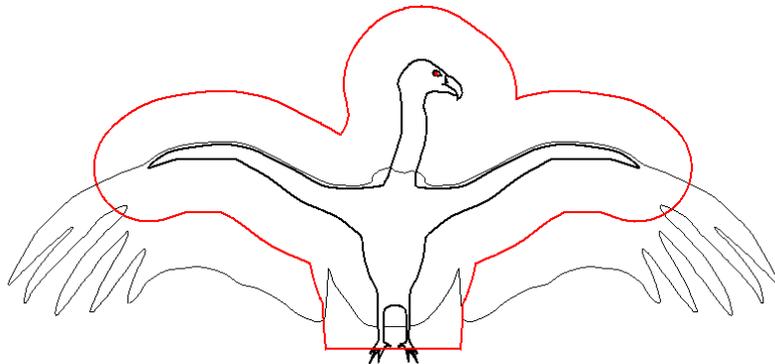
88KV SAFETY ZONE

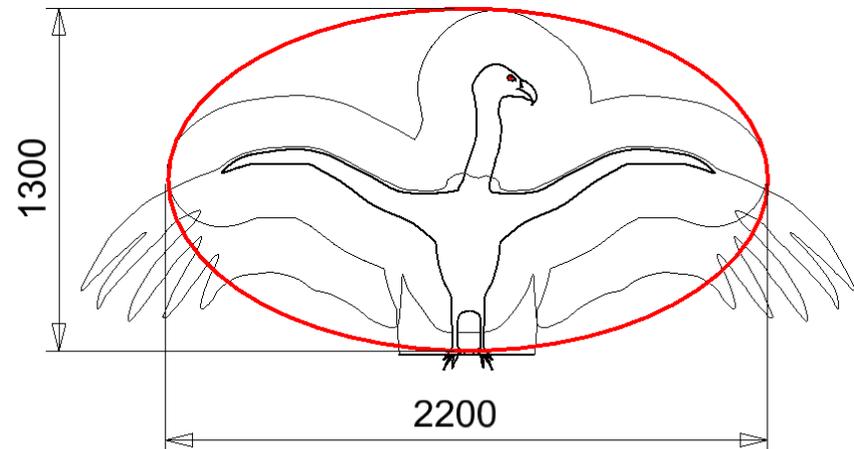
GEOMETRIC SHAPE SAFETY ZONE

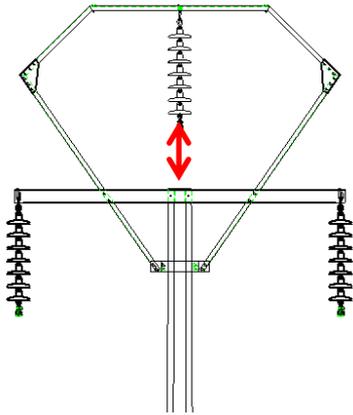
66/88kV Kite structure

'Window' too small

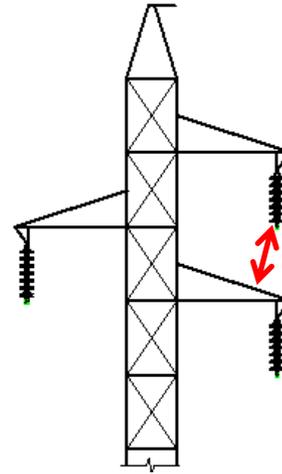
66/88kV Suspension

Bot. x-arm to top  
phase too small

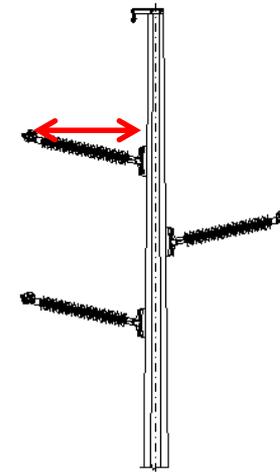
132kV DT 7611 Int.

New problem.  
Multiple Birds?

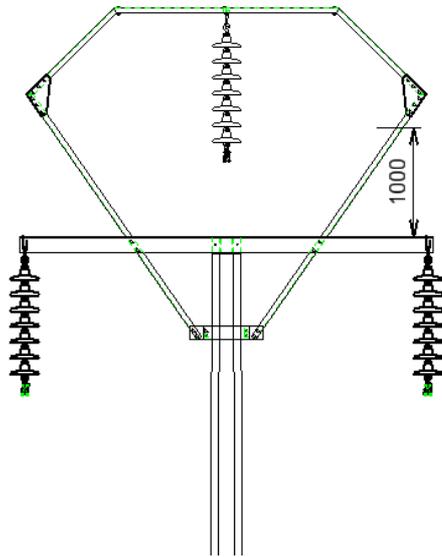
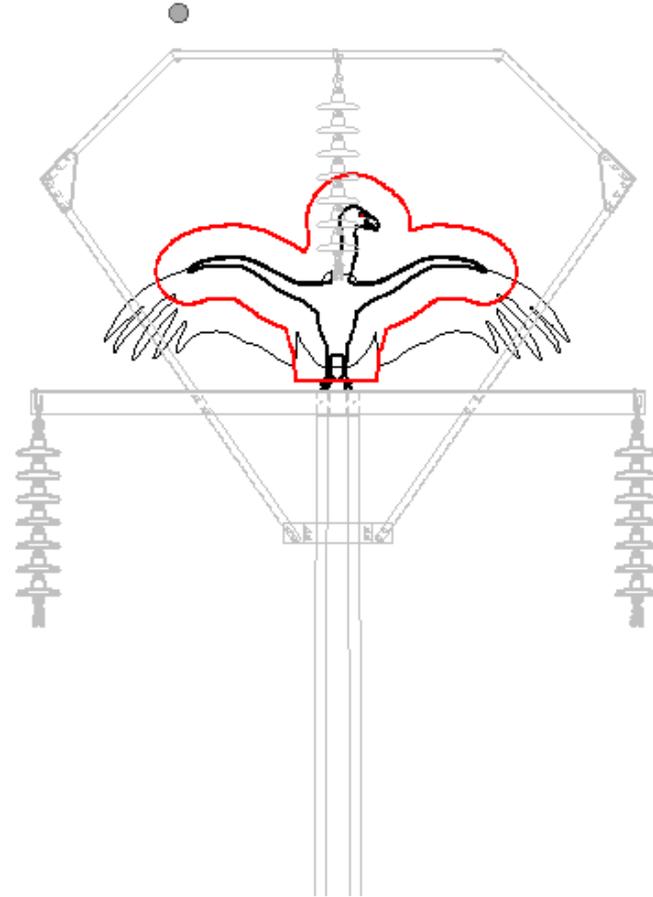
# 66/88KV Kite Frame – Turkey Test

- The kite frame fails the 'Turkey Test' miserably.
- Even if phase is insulated the bird can chew the insulation.
- Conductor needs to be raised

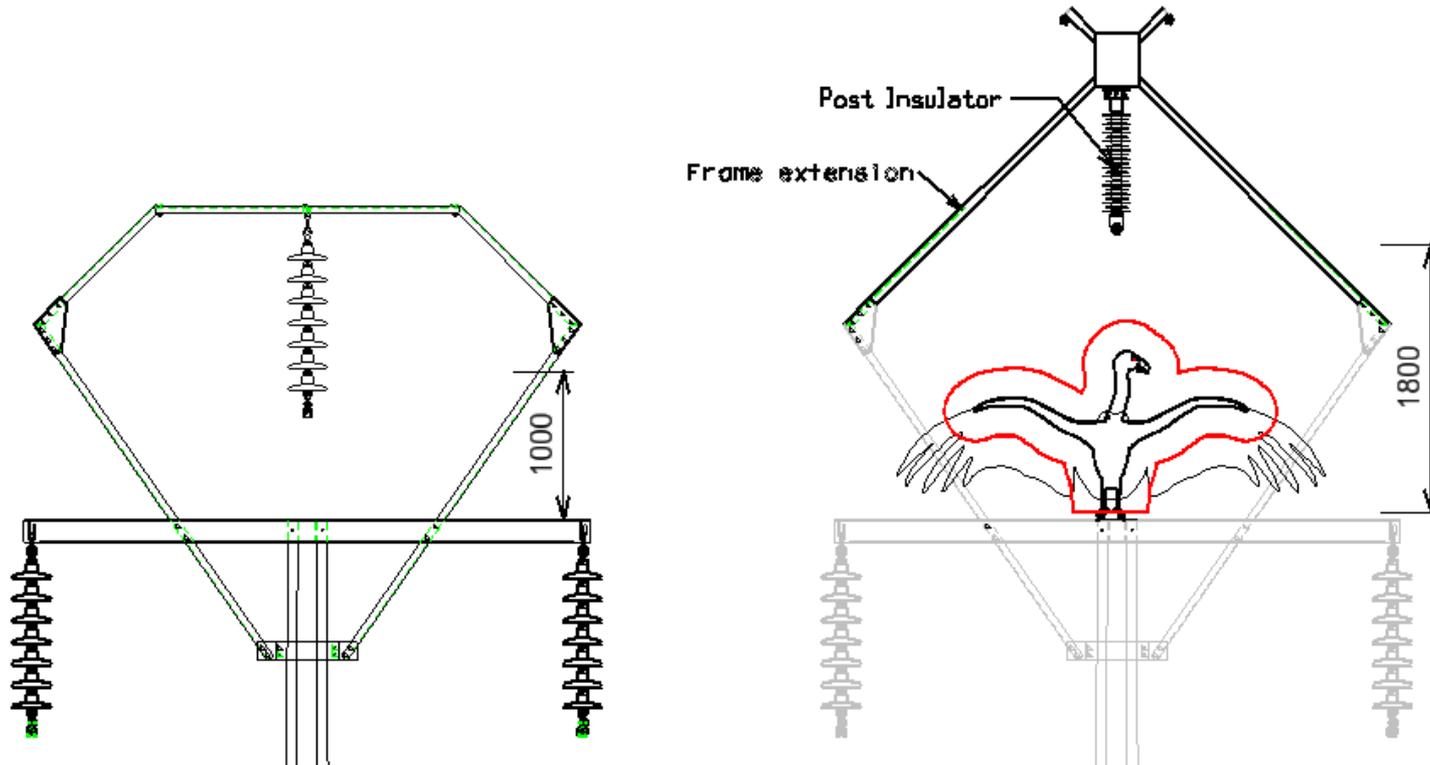
# 66/88kV Kite Frame Modification

- New top frame extension with inverted post insulator
- Passes 'Turkey Test' easily – if it does not sit on conductor!
- Composite x-arm frame extension being considered

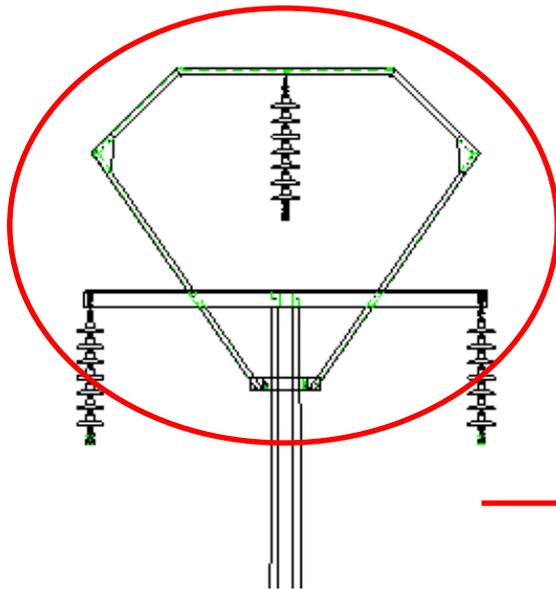
# 66/88kV Kite Frame Replacement

This whole kite  
frame is removed
