# ENDANGERED WILDLIFE TRUST

## Wildlife and Energy interactions: A South African perspective -2

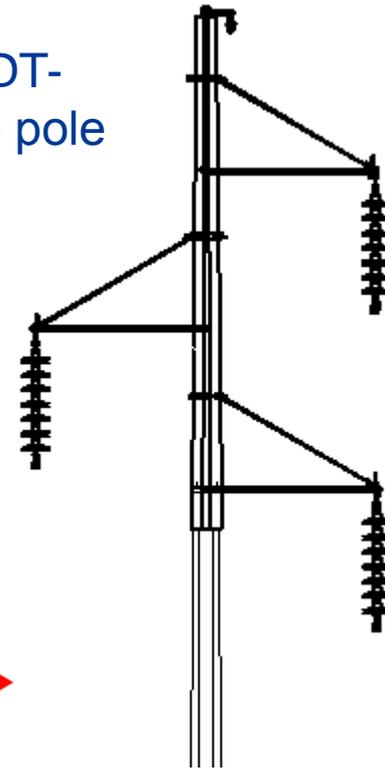
Replaced with 'D-DT-  
7649' top on same pole

- This method to become compulsory if restringing kites in vulture areas

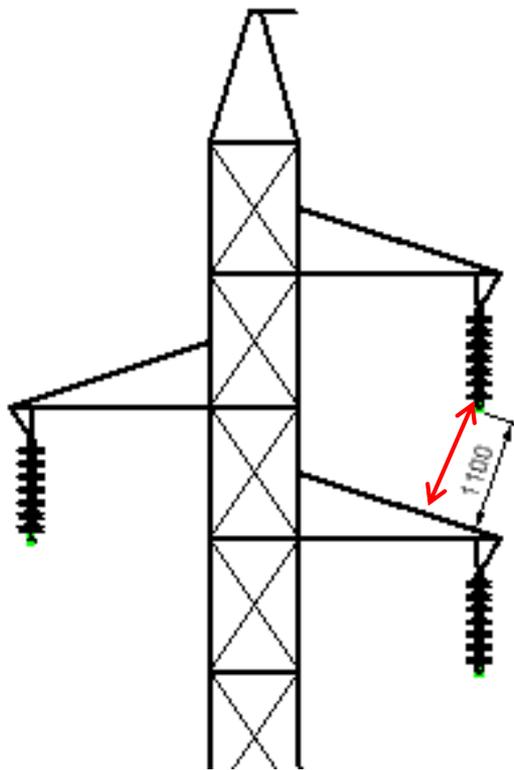
# 66/88kV Lattice Suspension Modification

The clearance from top phase to bottom x-arm is too small

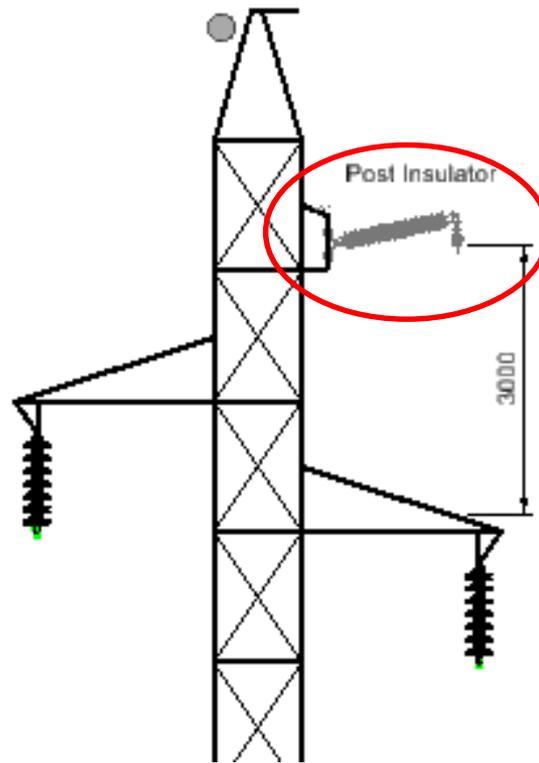
The top phase may be supported by a post insulator

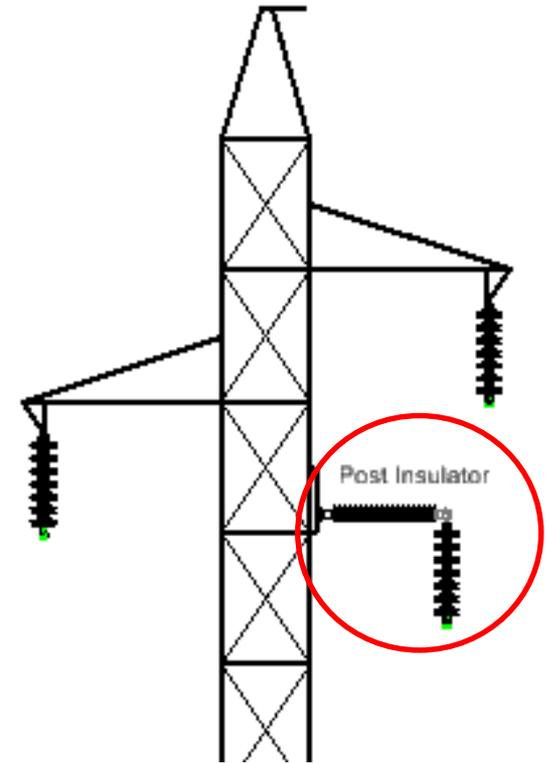
The bottom phase may be supported by a post insulator

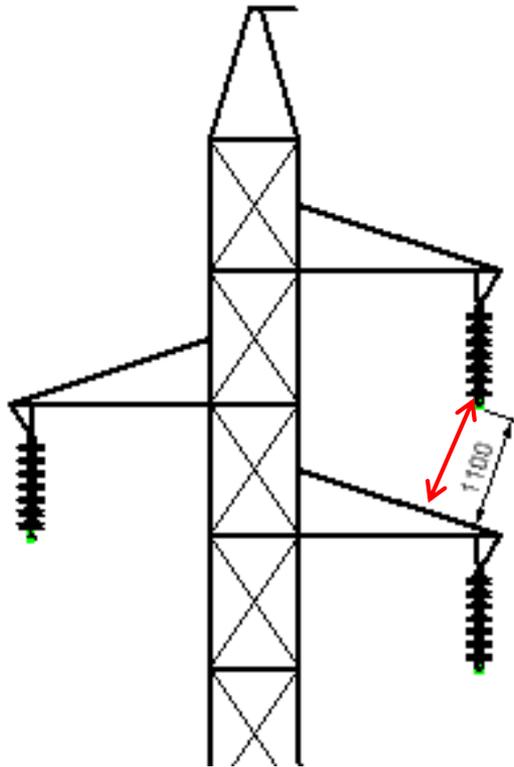
# 66/88kV Lattice Suspension Modification

The clearance from top phase to bottom x-arm is too small

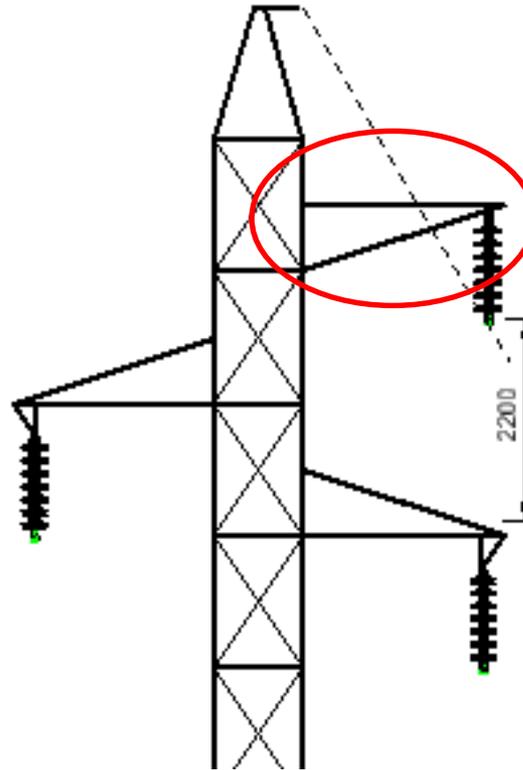
The top X-arm may be changed and 'hook' removed

In this case the removal of the hook alone may be adequate for a perching bird but not a landing one. Will differ between structure types.

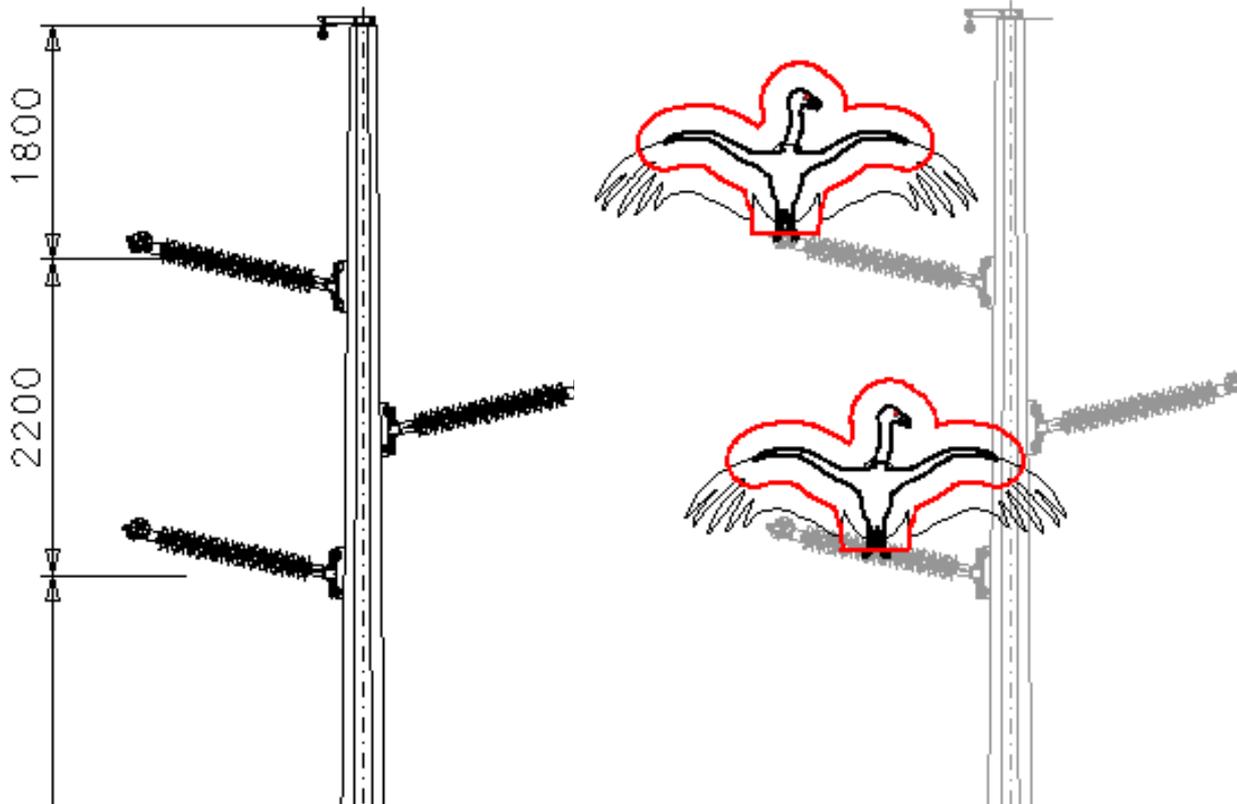
# D-DT-7611 Clearance Problem - Turkey Test

In the area where this occurred there is a very high density of vultures and it may well have been more than one bird trying to sit on the same insulator.

D-DT-7611 has been used for many years with no reported incidents. BUT..Polokwane fatalities

Turkey Test: Perching on the trunnion clamp is safe, but perching on the insulator is not.

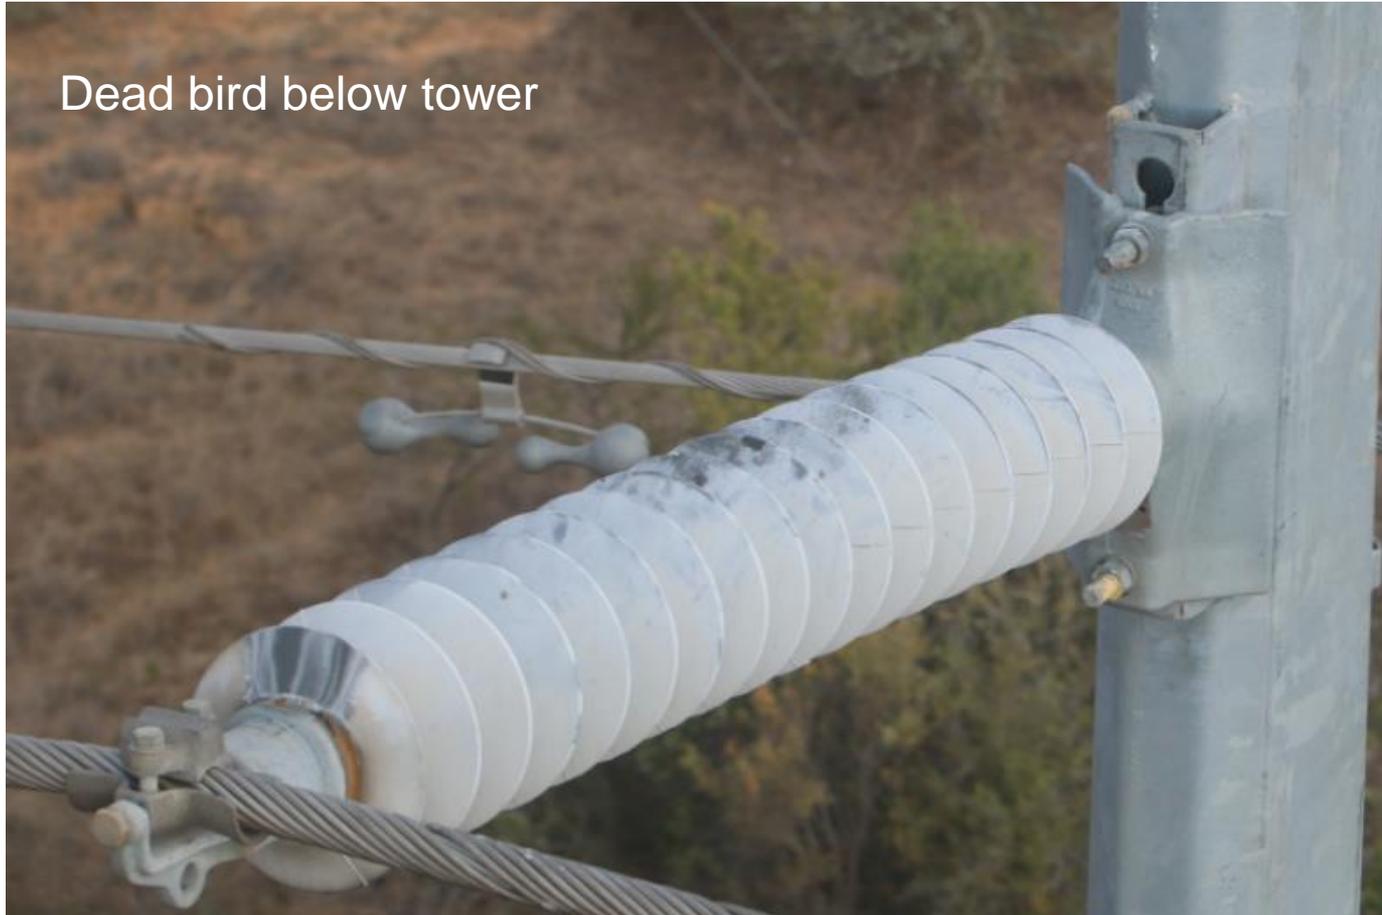
# D-DT-7611 Flashover

Dead bird below tower

Apparent evidence of a flash to the tower while bird was on insulator

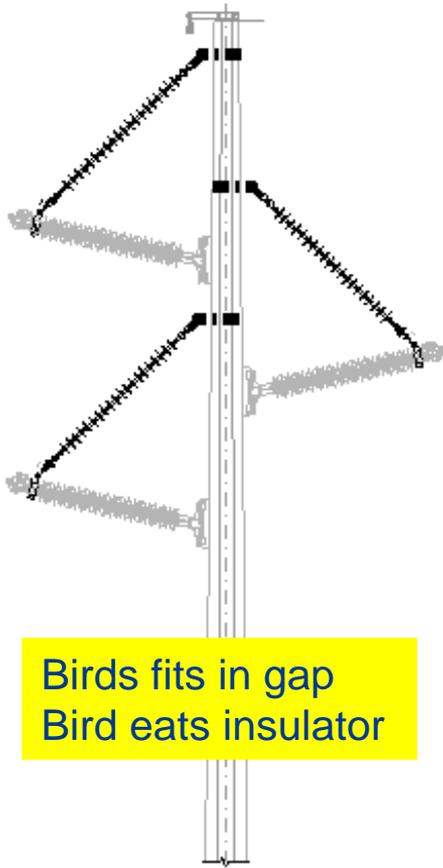
Birds fits in gap  
Bird eats insulator

ADD 'BRACE' INSULATOR

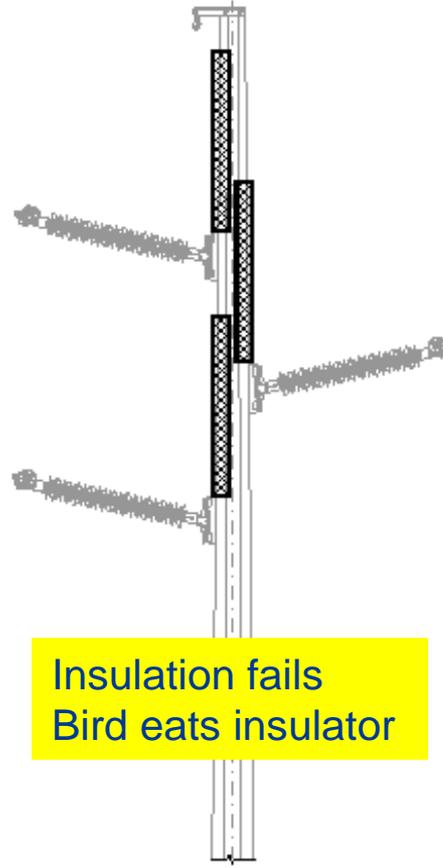
Insulation fails  
Bird eats insulator

ADD POLE INSULATION

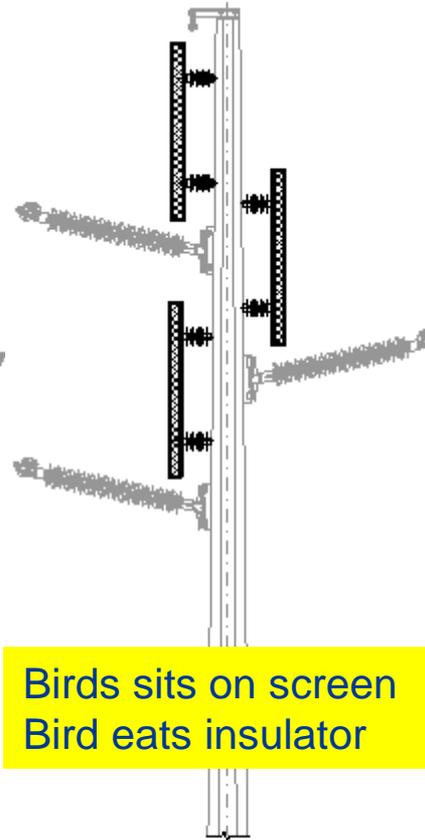
Birds sits on screen  
Bird eats insulator

ADD BARRIER  
ON POST INSULATORS

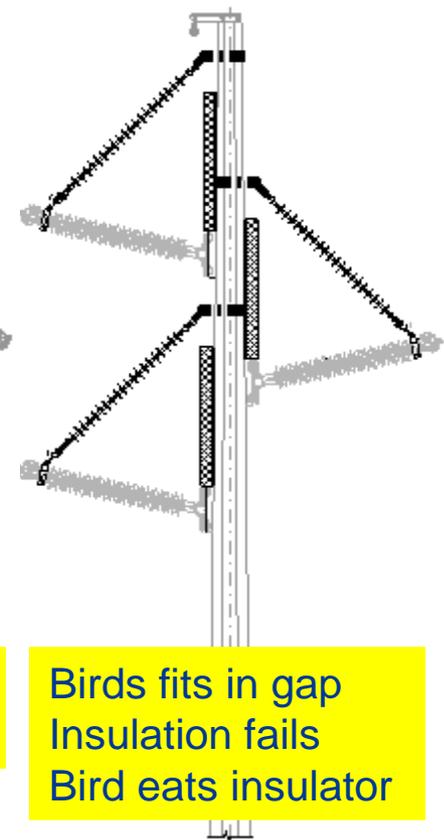
Birds fits in gap  
Insulation fails  
Bird eats insulator

ADD 'BRACE' INSULATOR +  
ADD POLE INSULATION

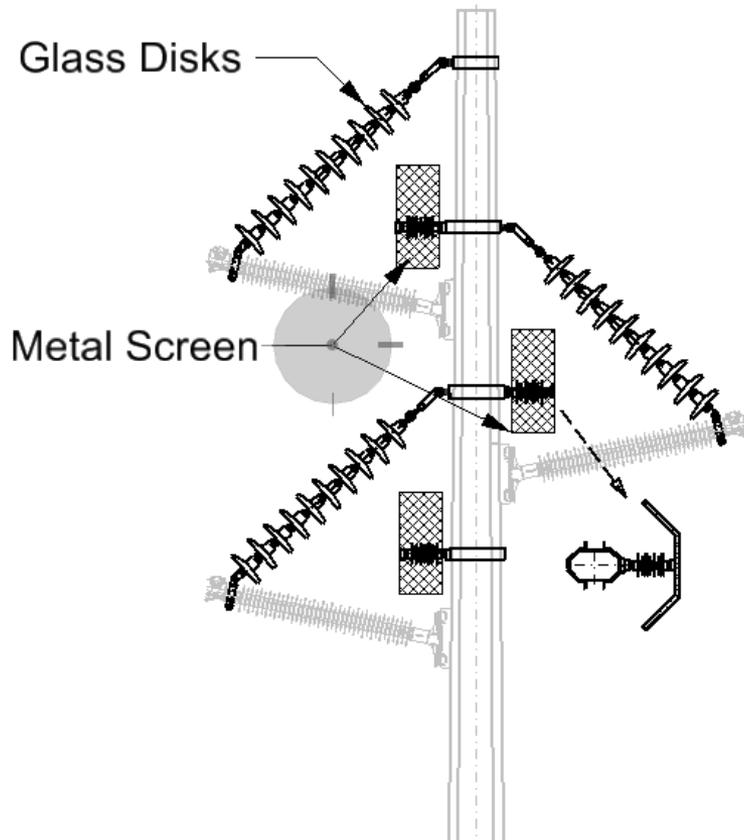
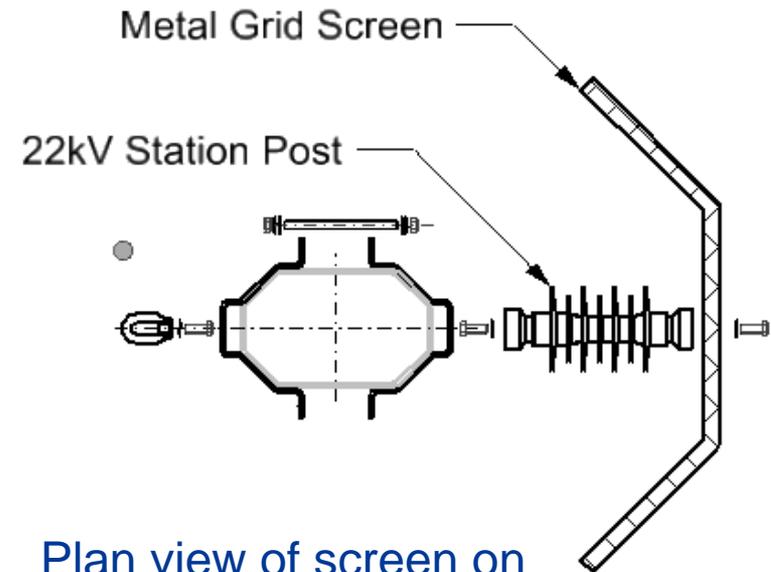
# D-DT-7611 Mitigation. Belts and Braces ☺

Plan view of screen on  
22kV post Insulator

Bird cannot eat insulator, fit in gap or sit on screen but: **Too much 'Stuff'?**

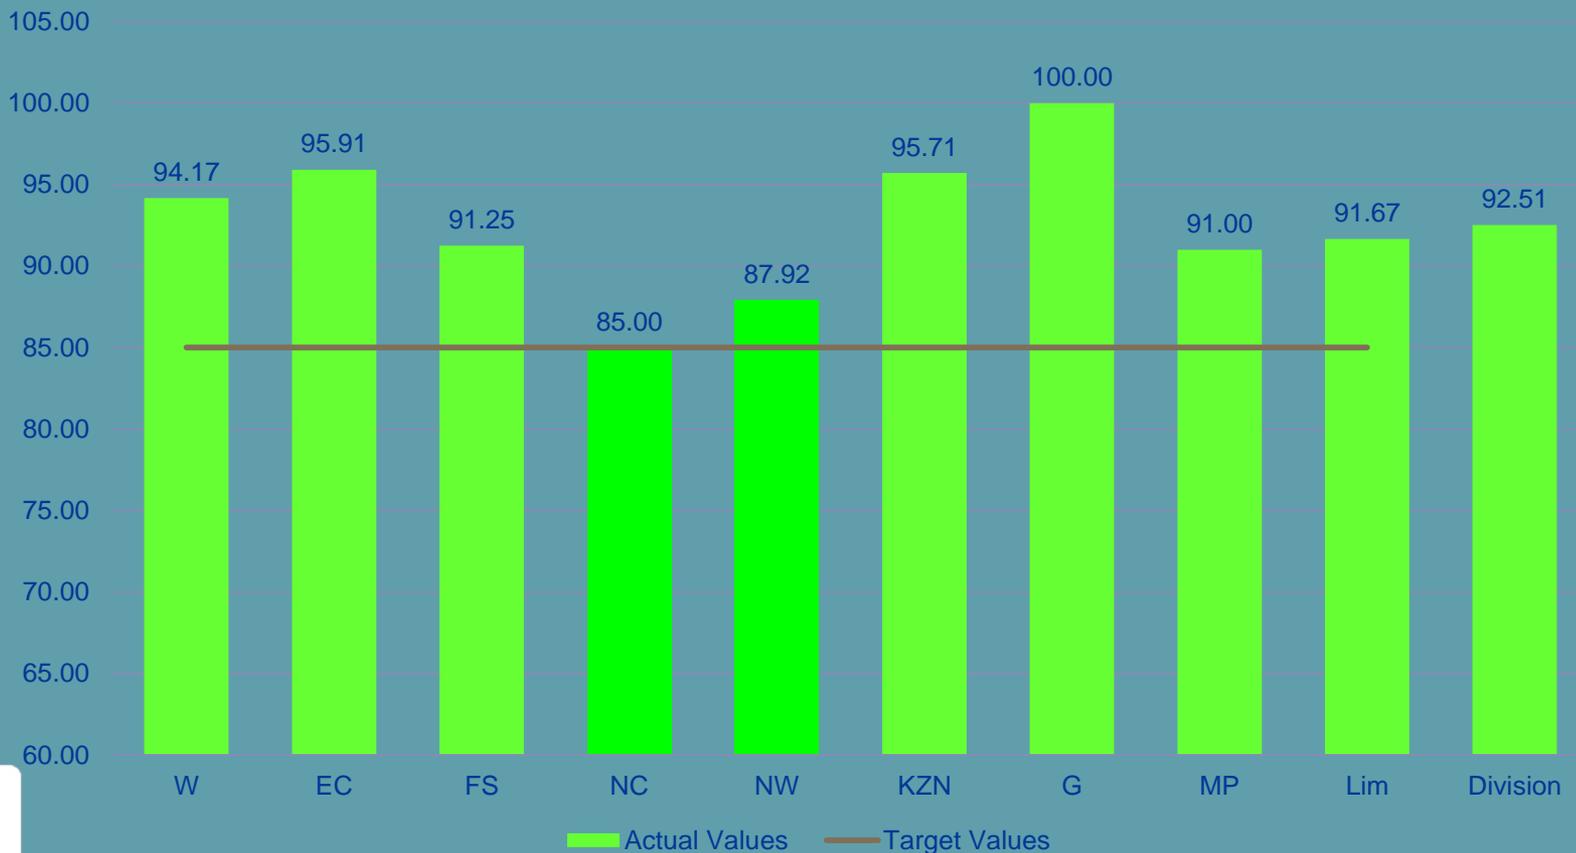
## 5. Percentage of Wildlife Interactions mitigated < 4 months

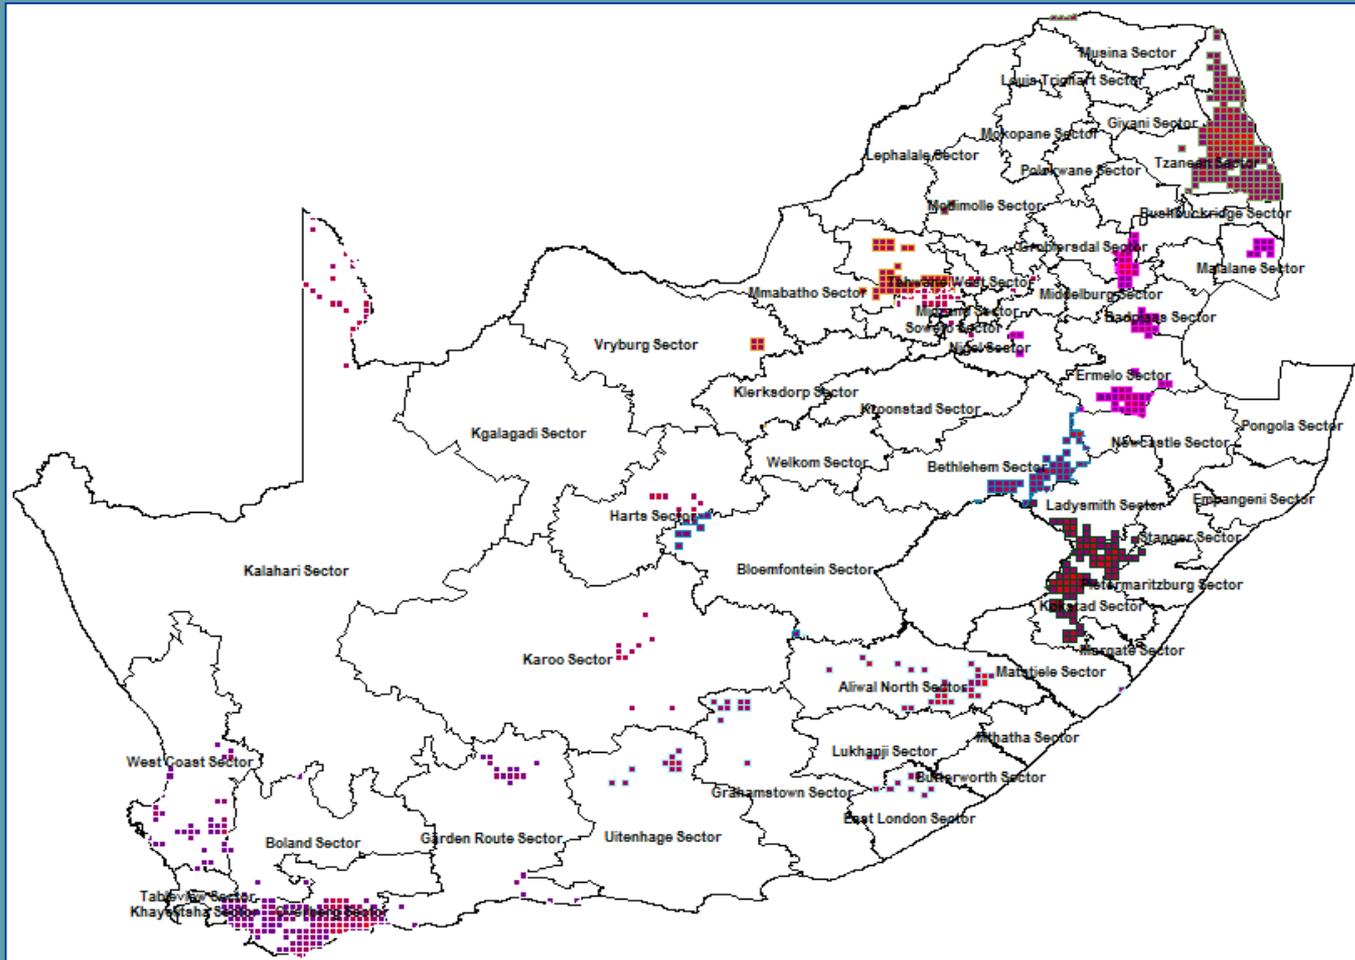
Bird Sensitivity Map indicating Hot Spots for immediate attention

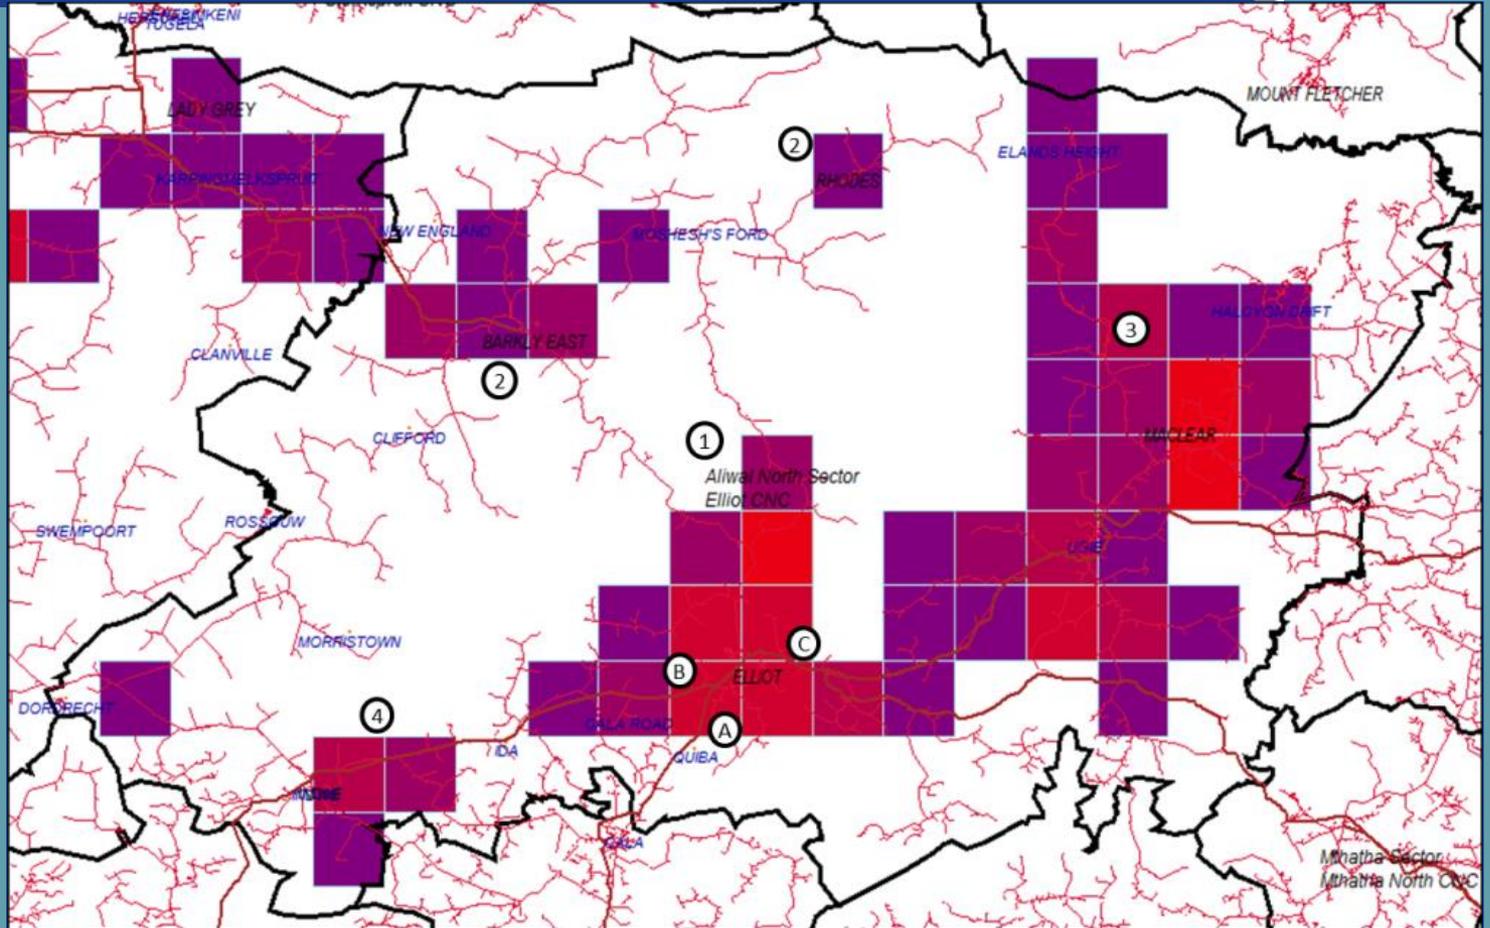
Elliot CNC sensitivity pentads overlaid with the HV and MV power lines

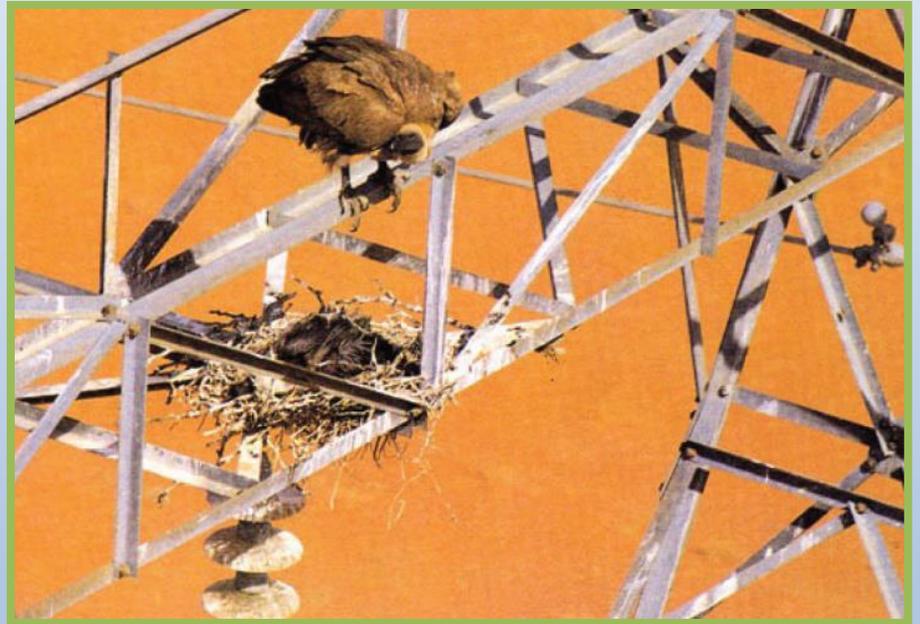
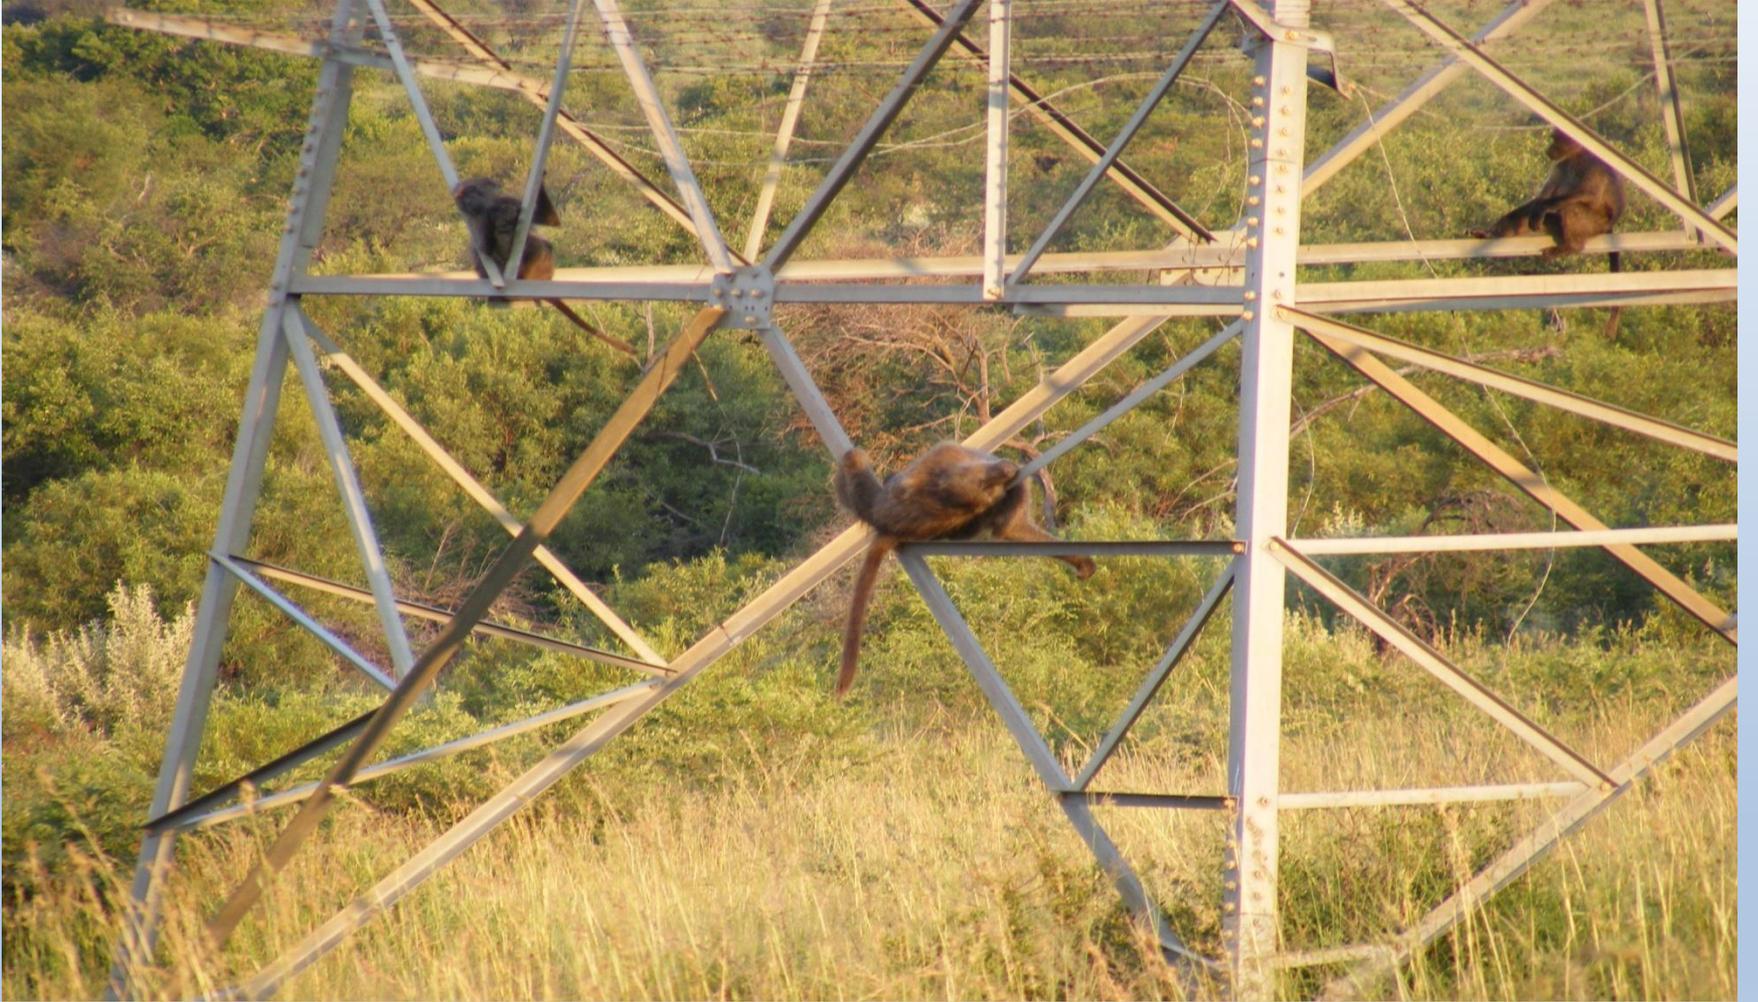
## Streamers & Pollution

# Problems associated with nests

If a nest is located above a critical area (conductor) a flashover can result.

If nest is situated above an insulator string the disks may become polluted over time

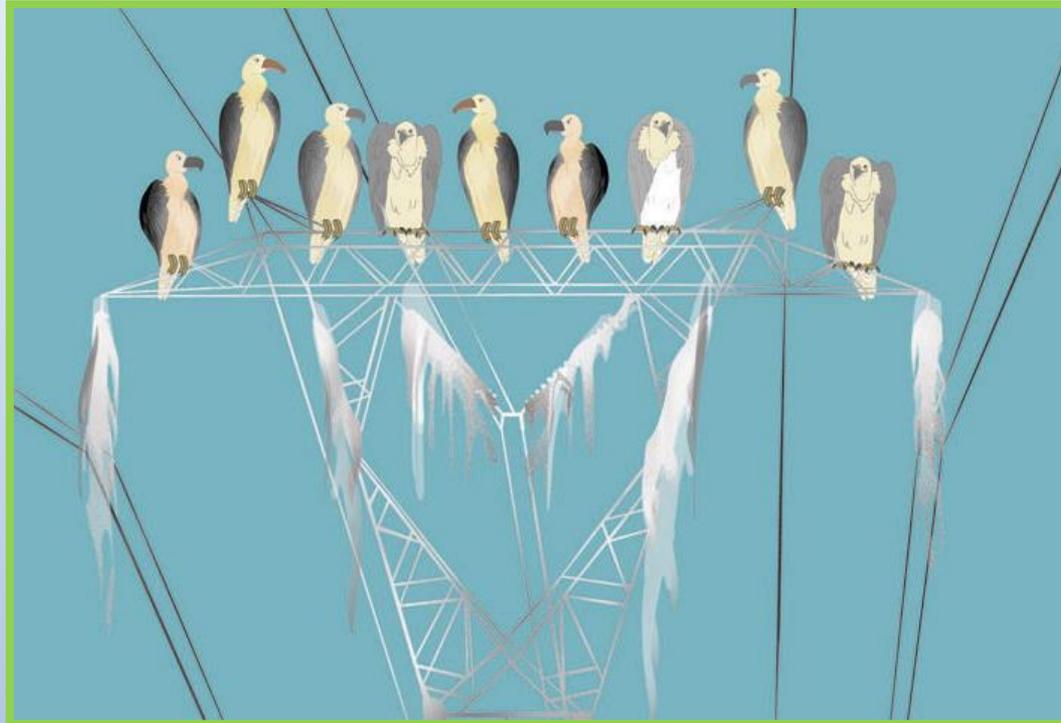
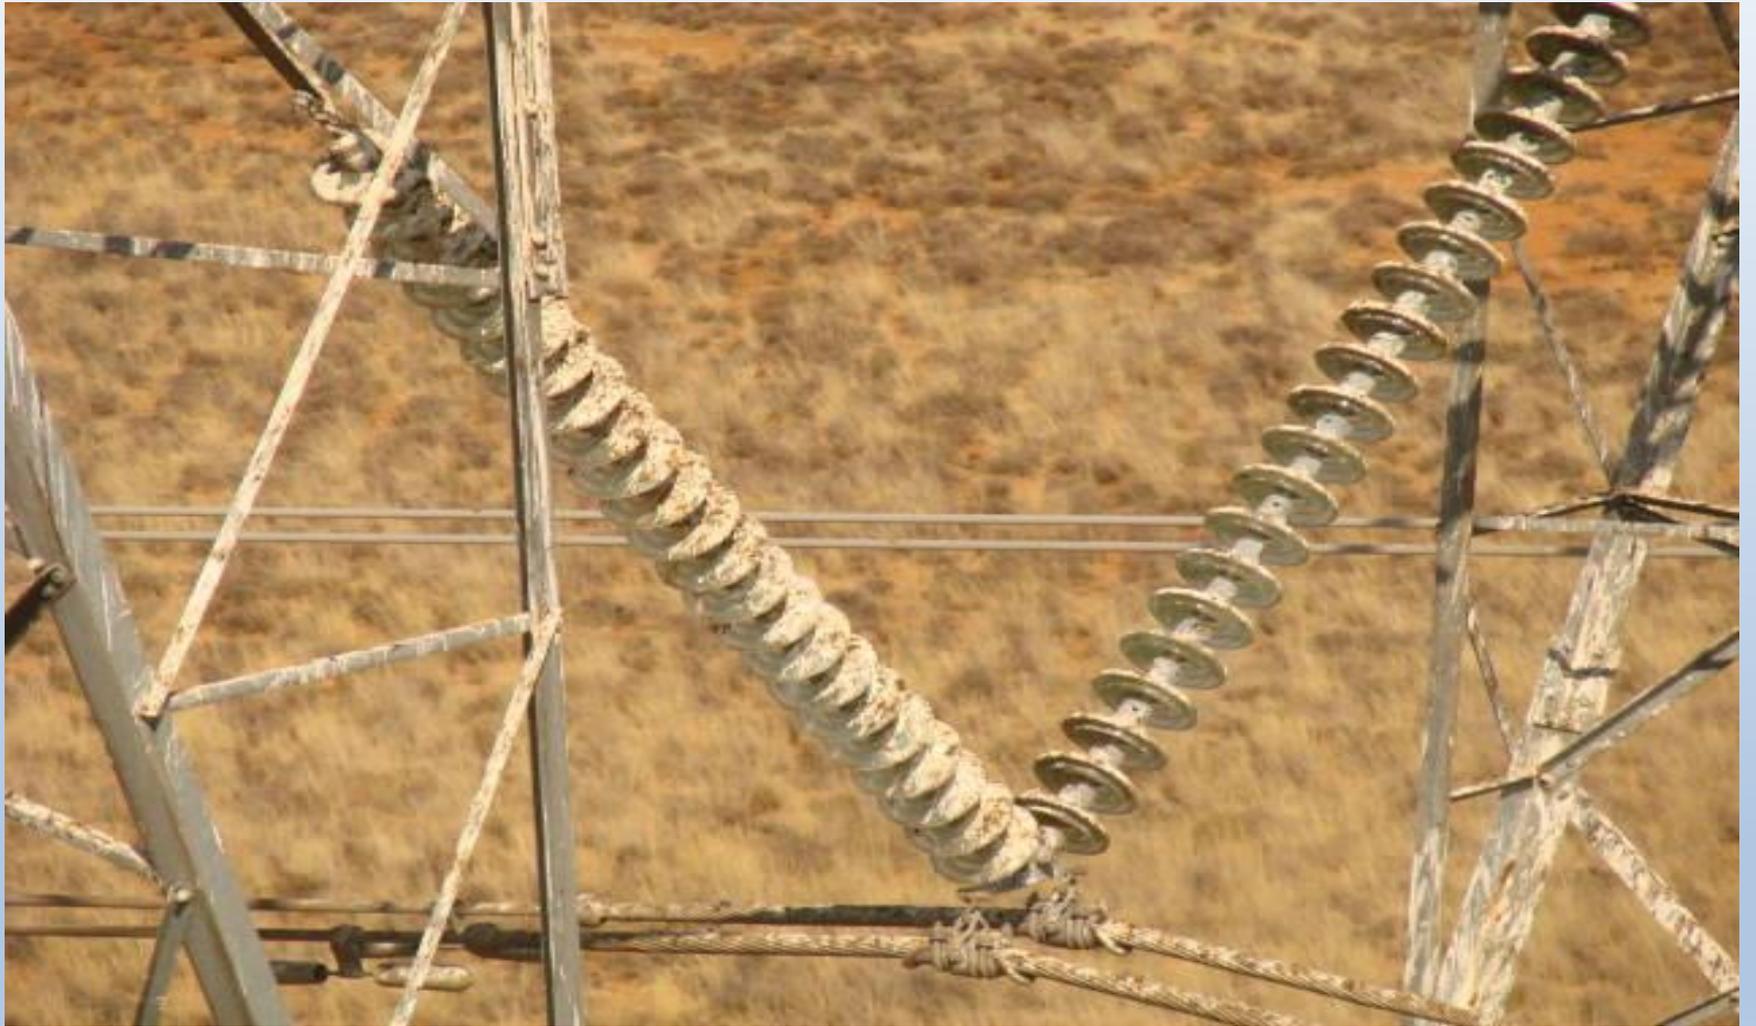
# Bird Pollution

Repeated pre-deposition of excreta on insulators coupled with moisture

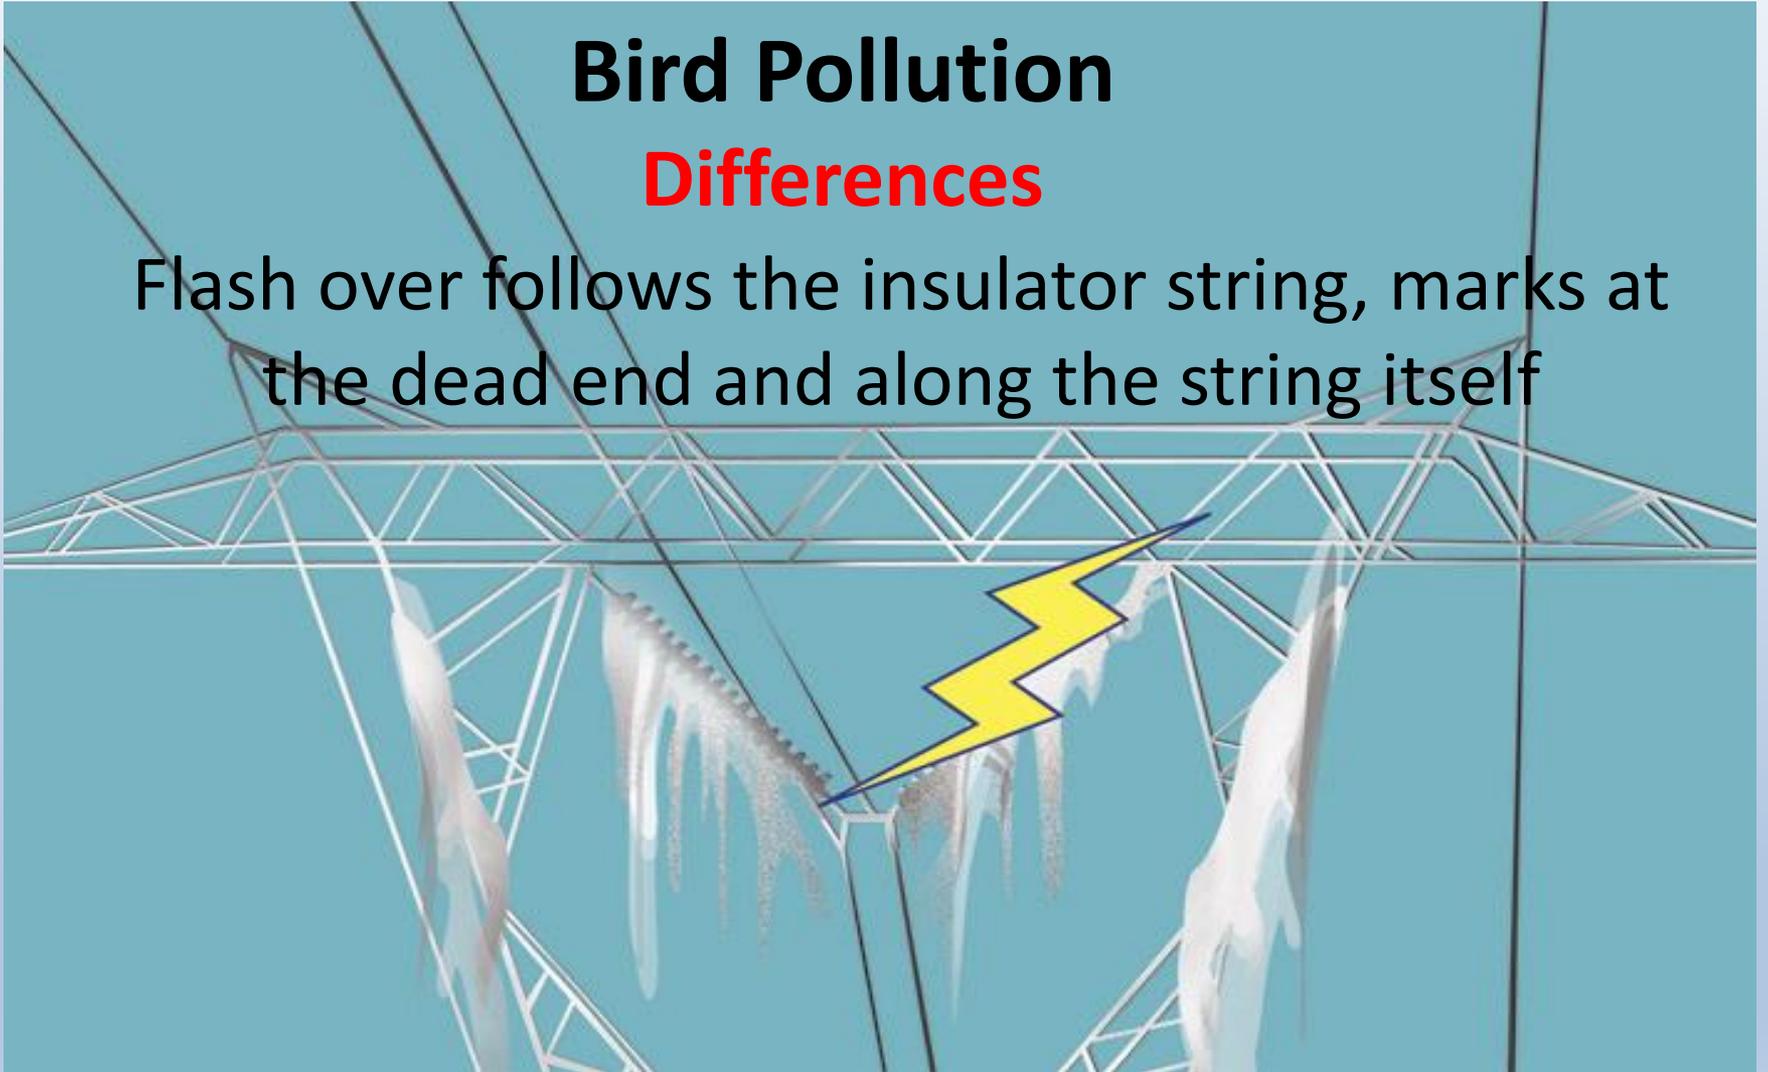
# Bird Pollution

## Differences

Flash over follows the insulator string, marks at the dead end and along the string itself

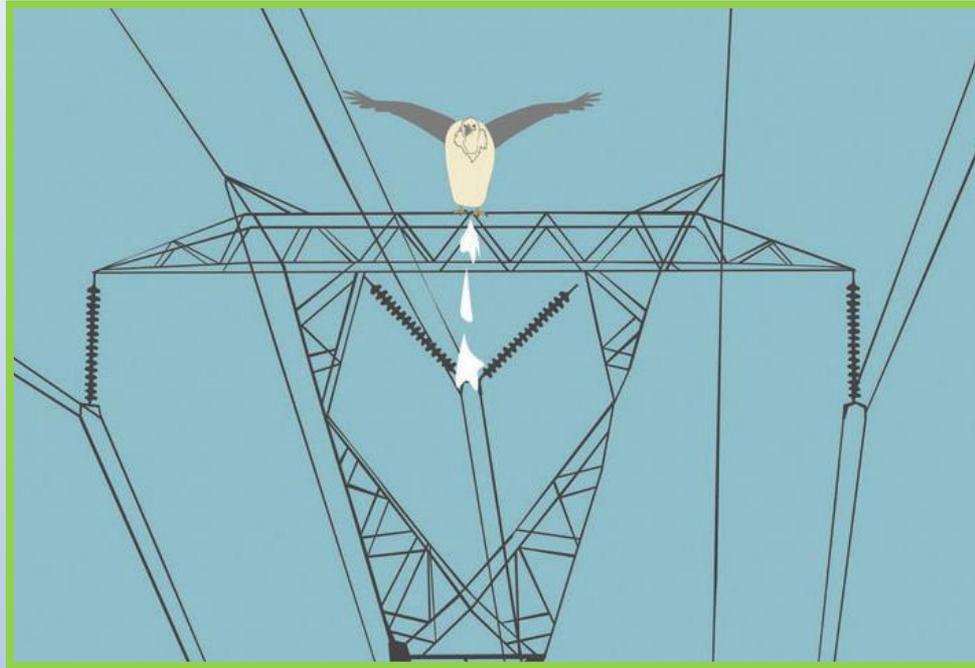
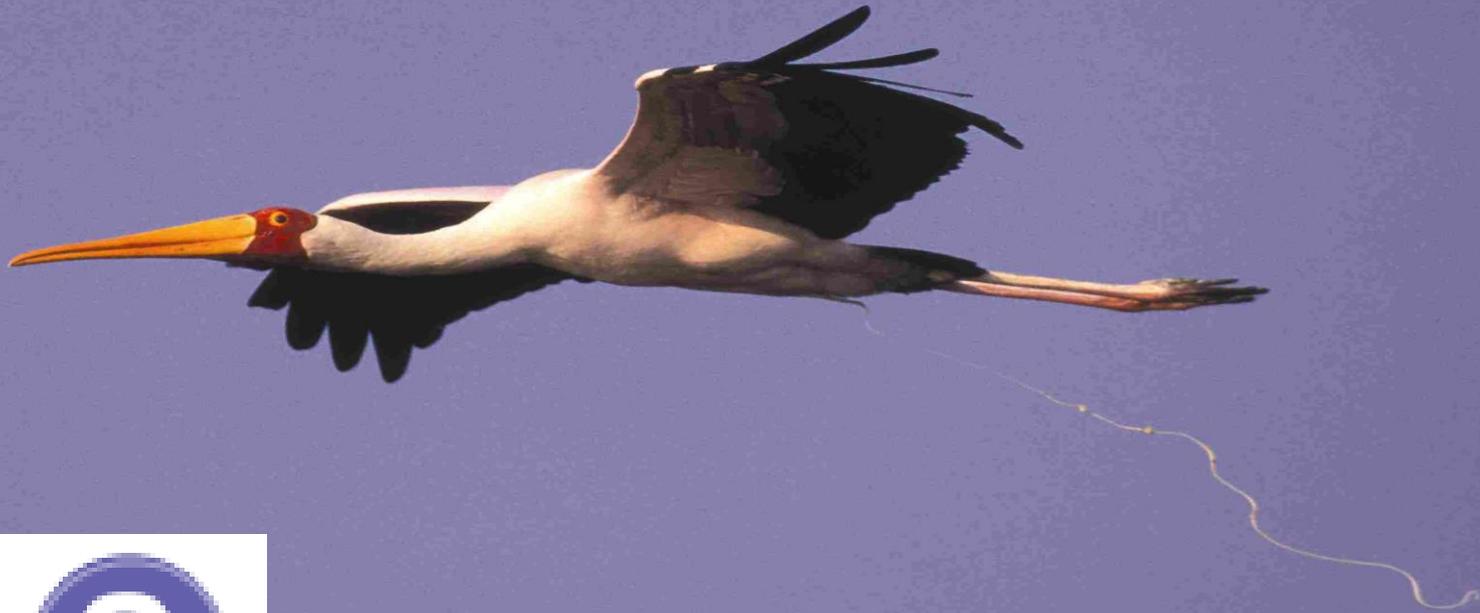
# Bird Steamer

Bridging of the air insulation by means of a continuous long ejected streamer of electrically conductive excreta

**BIRD STREAMER**

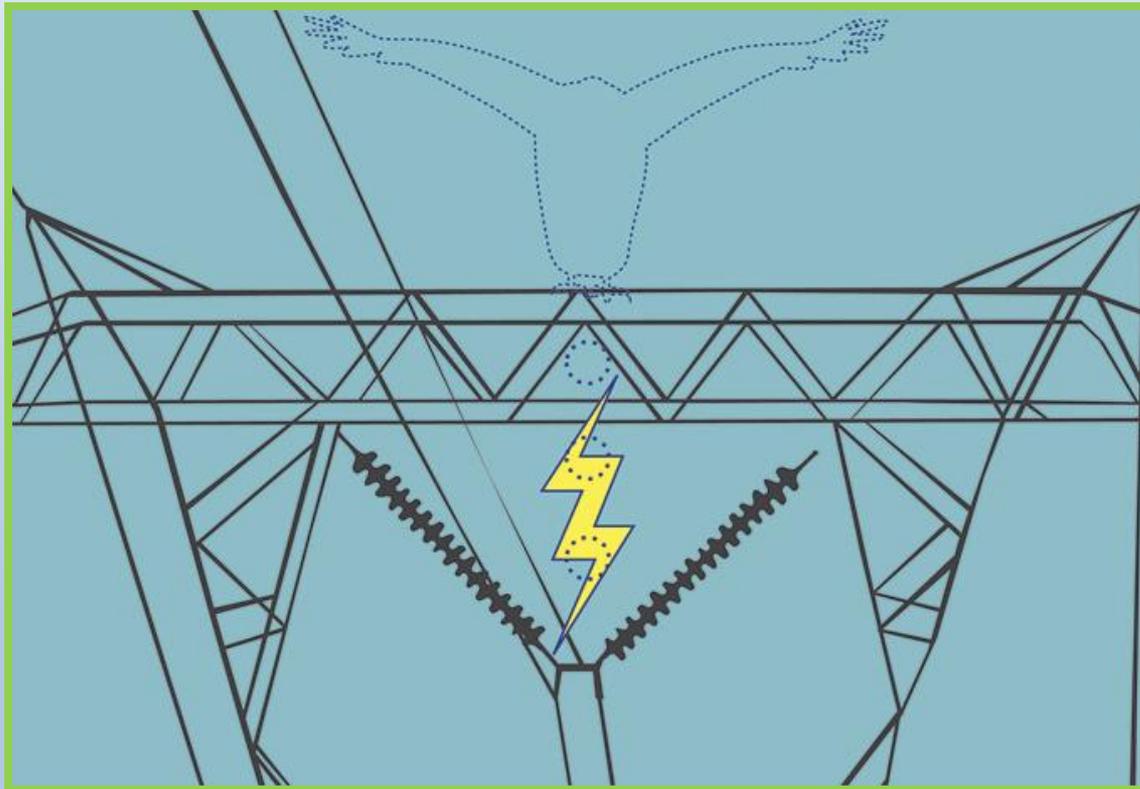
# Indicators of Bird Streamer Faulting

Position of the flash marks

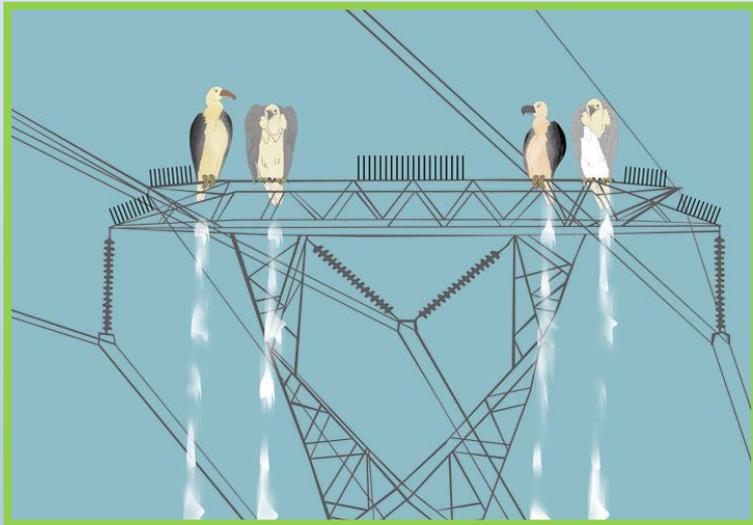
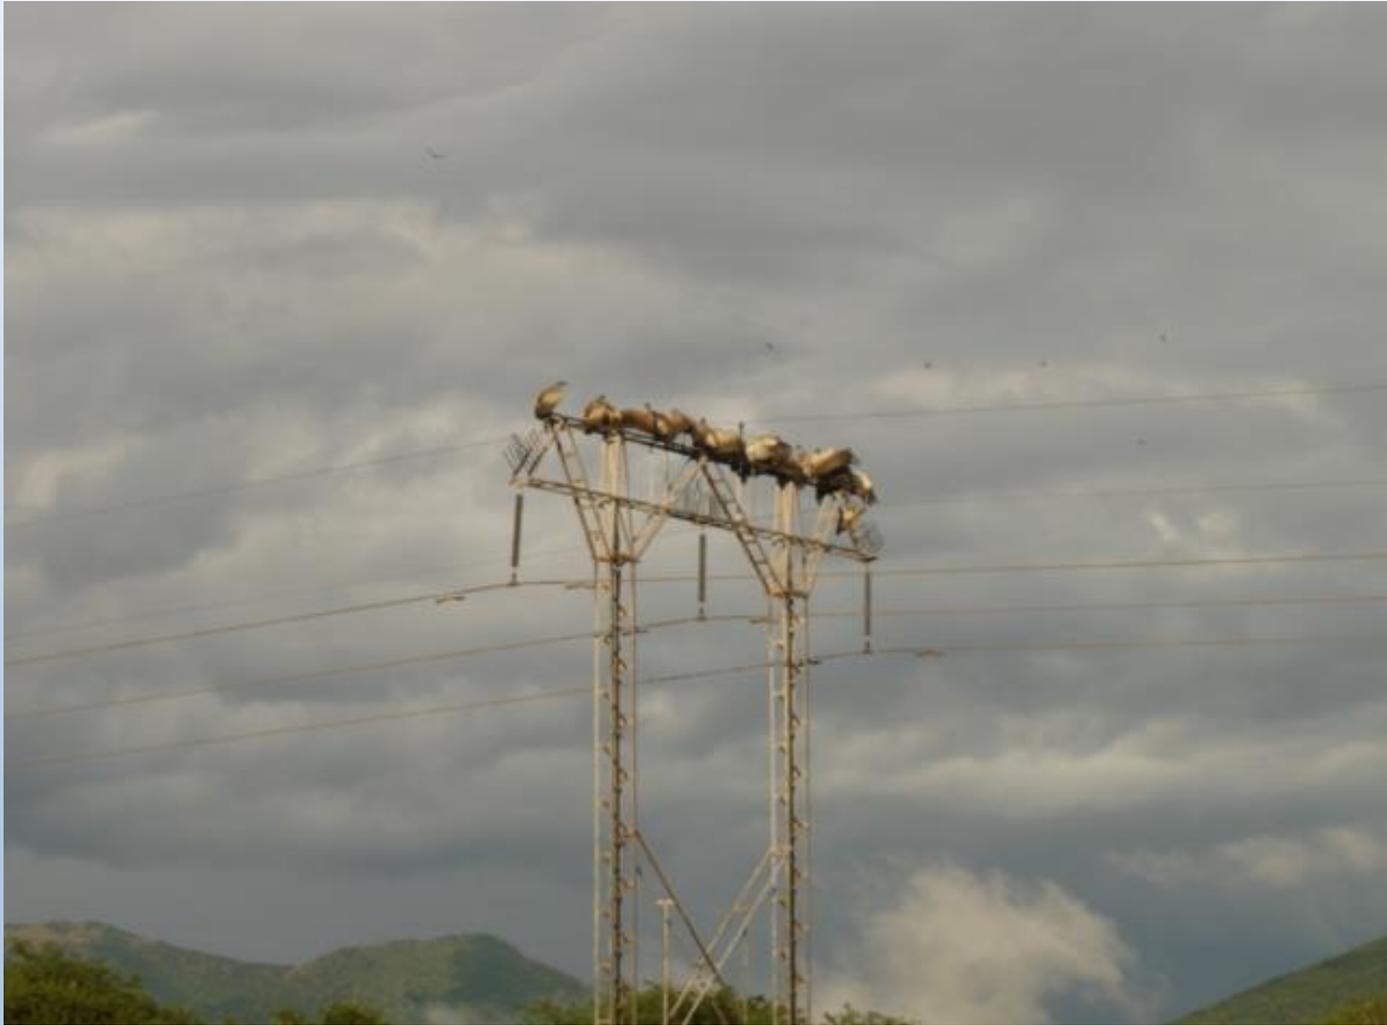
## Bird Guards

# Mitigation

- Installed in a zone at least 1m on either side of the conductor bundle
- Landing plates on strain towers
- V and I string configurations
- Areas inside the boat
